Lightning Protection of Residential AC Wiring

Number MOR-78-095

LIGHTNING PROTECTION OF RESIDENTIAL AC WIRING

New transient suppressors using metal oxide varistors offer improved protection of appliances and consumer electronics against overvoltages. This improvement, however, could be at the risk of imposing excessive duty on the suppressor in case of a very severe lightning stroke near the house where these suppressors are installed.

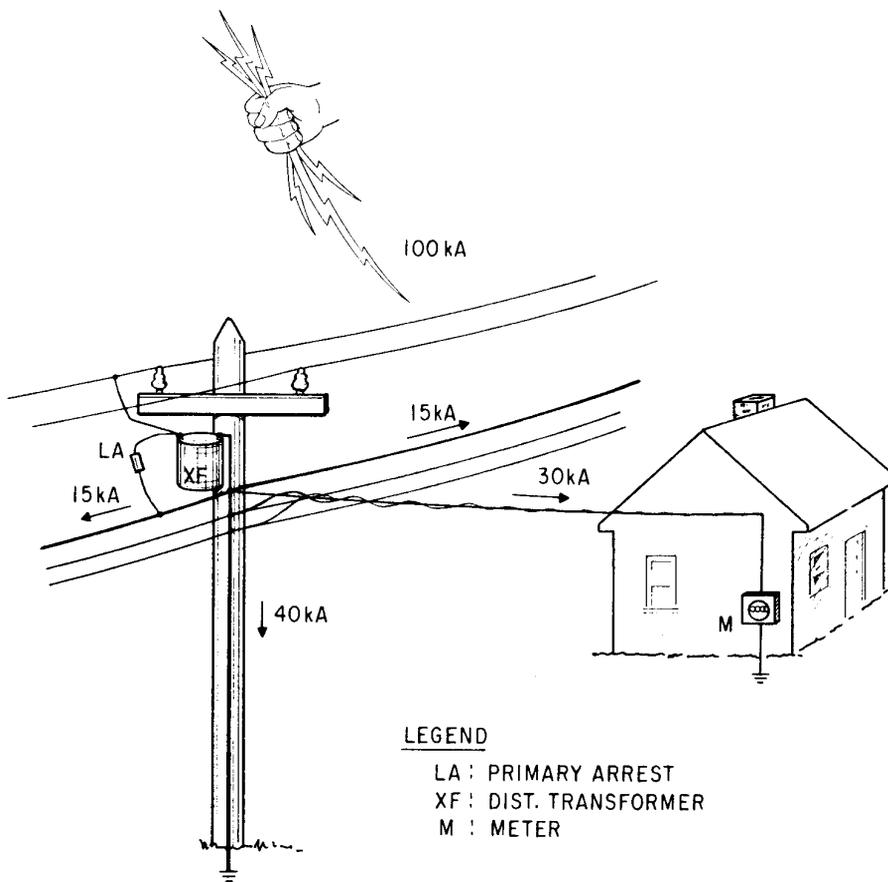
Figure 1. Division of Current Assumed for a 100 kA Stroke

It was postulated that a lightning stroke attaching to the primary side of an overhead distribution system would produce a branching of the current flow into the ground, following sparkover of the surge arrester, which was presumed connected at the pole-mounted distribution transformer. Figure 1 shows the assumed circuit and the division of current flow.

For the secondary side, however, the assumption was made that both sides (phases) of the center-tapped (grounded) secondary remained uninvolved in conducting the direct lightning current, while the ground wire (messenger) from pole to house carried its share, as defined in Figure 1.

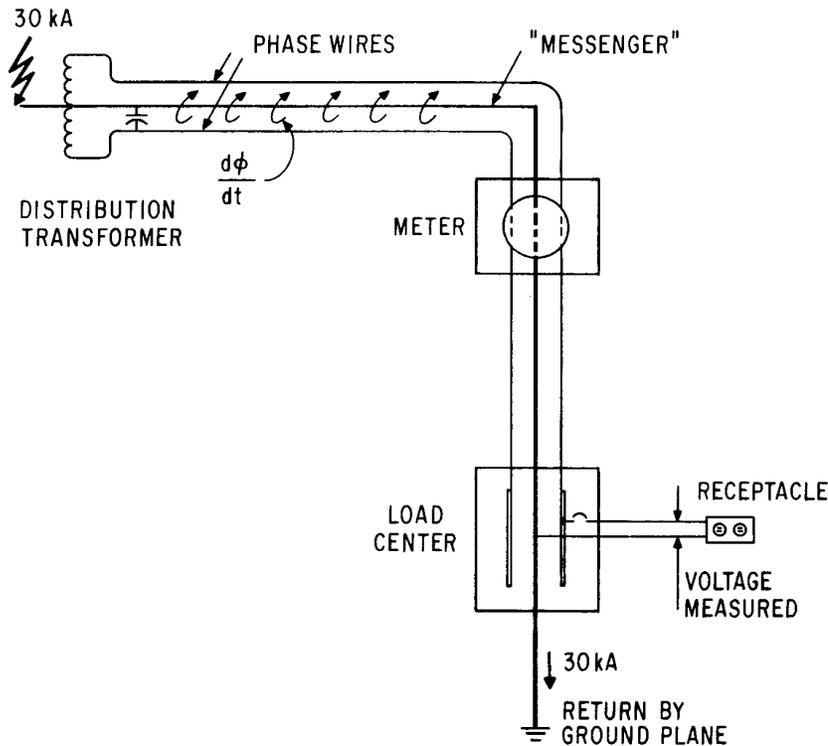
Figure 2. Voltages Induced in the House Wiring Systems

The generation of transient voltages in the house is attributed to electromagnetic coupling of the field established by the lightning current flowing in the messenger into the loop formed by the two phase wires encircling the messenger. In addition, there is some capacitive coupling between the wires (Figure 2).

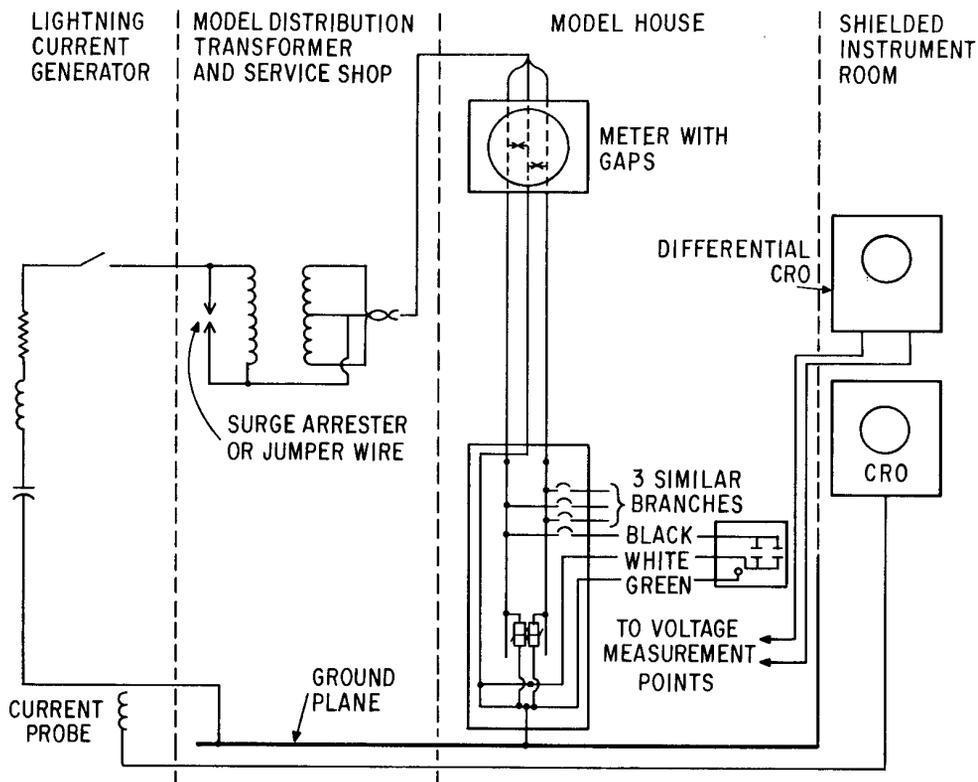
Figure 3. Schematic Representation of Test Circuit

The test circuit consisted of a high-current impulse generator, a distribution transformer with service drop, a simulated simplified house wiring system, and the necessary shielded instrumentation (Figure 3). Details of the catalog numbers, characteristics, etc., are given in the Appendix.

The service drop connection between the distribution transformer and the meter socket was made with three AWG #6 wires, twisted at a pitch of about 5 turns/m (1.5 turns/ft), 13 m (45 ft) long. This service drop was folded in a loose "S" shape, at about 0.5 m (1.5 ft) above the ground plane serving as the return path for the lightning current, in order to reduce the loop inductance seen by the generator. This configuration does not influence the coupling between the messenger and the wires wrapped around it, coupling which has been identified as the voltage-inducing mechanism.

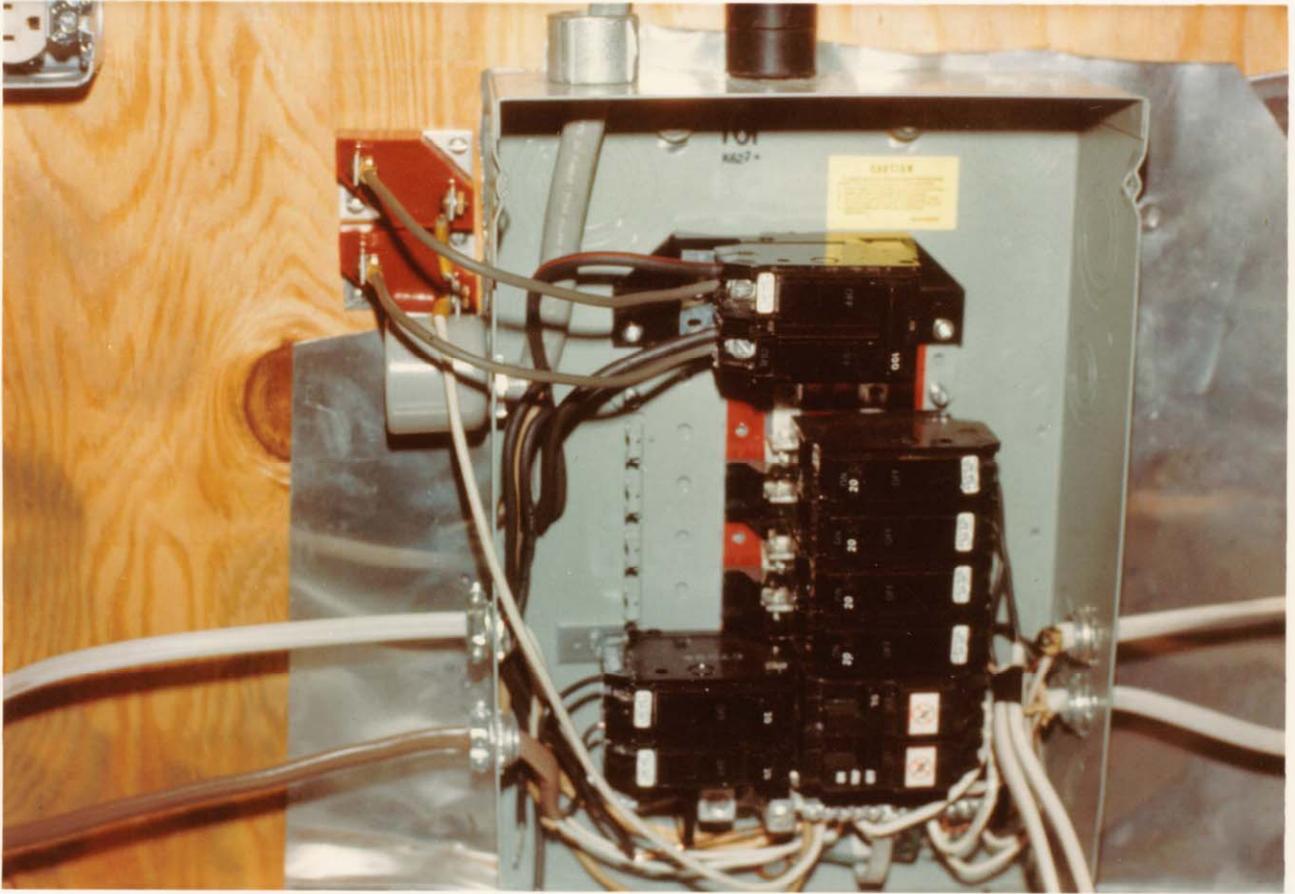
Figure 4. Connections at Load Center

The simulated house wiring started at the meter socket and continued to a load center by a 3 m (10 ft) length of AWG #6 aluminum entrance cable. The meter socket, watt-hour meter, and load center were typical General Electric Company hardware (see Appendix), except as noted in the detailed procedure description. From this load center, four "branch circuits" connected to the load center breakers were established, each terminating at a wall receptacle mounted on the same 1.2 by 2.4 m (4 by 8 ft) plywood panel on which the watt-hour meter and load center were also mounted. The branch circuits' lengths were (one each) 6, 12, 24, and 48 m (20, 40, 80, and 160 ft), the wire being loosely coiled between the load center and receptacles (Figure 4).

For all tests with no specific reference to that assumption, the simulation circuit had, in fact, the high side (H1) of the transformer primary connected to the neutral/ground of the transformer by a jumper wire (see Figure 4).

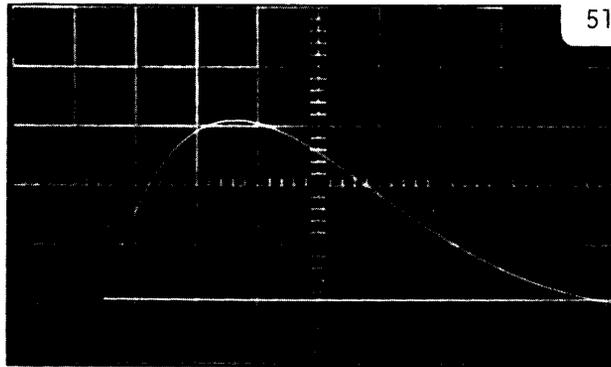
Figure 5. Applied Current Waveshape - 1.5 kA Crest, 10 x 25 μ s

Preliminary tests indicated that flashover at the receptacles would occur with 10 kA injected into the ground messenger, but no sparkover of the meter gaps was apparent. Therefore, a first test series was conducted at only 1.5 kA in order to provide consistent patterns of wave propagation undisturbed by flashover (Figure 5).

VERTICAL - 500 A/div

HORIZONTAL - 5 μ s/div

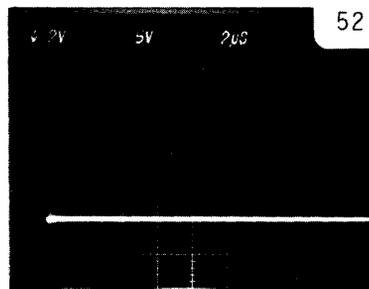
Figure 6. Typical Noise Response of Measurement System with 1.5 kA Injection

Noise checks were made for the voltage measurement system by shorting the probes together and attaching them to the neutral point on the circuit under test. Similarly, the center conductor of the cable to the current transformer was removed from the transformer output and connected to its sheath. No significant voltages (greater than 5% of measured signal) were measured. A typical noise check oscillogram is shown in Figure 6.

VERTICAL - 5 V/div

HORIZONTAL - 2 μ s/div

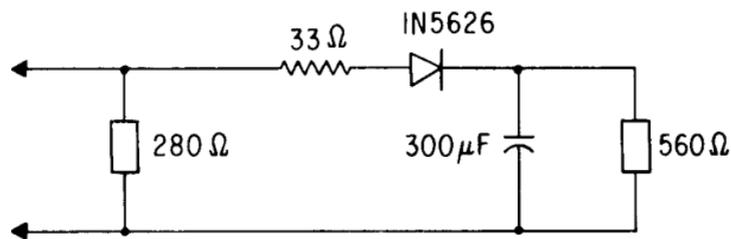
Figure 7. Television Input Stage

Since the worst case (little attenuation) is expected when there is little load connected to the system, most test measurements were made without loads attached to the outlets in the simulation. Measurements were also made with typical house loads connected to the outlets. These loads were a 100 W light bulb, which was represented by a $130\ \Omega$ resistor, a 1/2 hp single-phase induction appliance motor, and the input stage of a television circuit, as shown in Figure 7.

The unsymmetrical load (diode) of the TV input circuit behaved in a predictable manner: when the polarity of the voltage was such that a forward bias was applied, the diode clipped the voltage, with the series resistance limiting the current. With reverse bias polarity, the diode failed when the 2500 V transient occurred at that outlet.

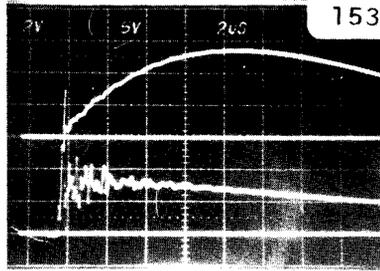
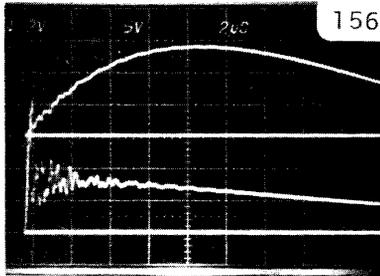
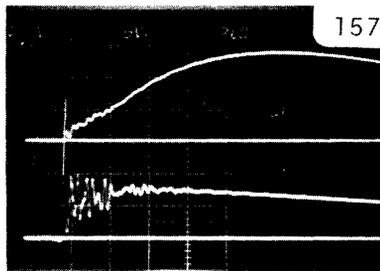
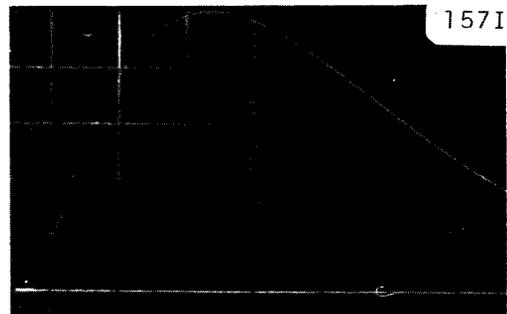
Figure 9. Comparison of Protector HLP Response for Various Protective Devices at the Primary of the Distribution Transformer

Replacing this jumper by an air gap (Oscillogram 156 in Figure 9) or by a distribution arrester (Oscillogram 157) did not produce a significant change in the voltage observed at the bus in the load center. Furthermore, the current injected for the case of the arrester (Oscillogram 157I) is slightly, but not significantly, affected during its rise time. These two observations validate the use of a jumper around the transformer primary.

VOLTAGE AT BUS WITH H1 OF
TRANSFORMER TIED TO
NEUTRAL (GROUND)

VOLTAGE AT BUS WITH AIR GAP
BETWEEN H1 OF TRANSFORMER
AND NEUTRAL

VOLTAGE AT BUS WITH
DISTRIBUTION ARRESTER ON
TRANSFORMER PRIMARY

CURRENT INJECTED FOR
TEST 157
(The arrester affects
the front of wave of
the current)

Test Condition: 10 kA injected.
All sweeps: 2 μ s/div, except 157I

In the simulation of the system, the circuit configuration at the pole and distribution transformer assumed that the lightning stroke had terminated on the primary conductor and that the primary arrester installed to protect the distribution transformer had sparked over.

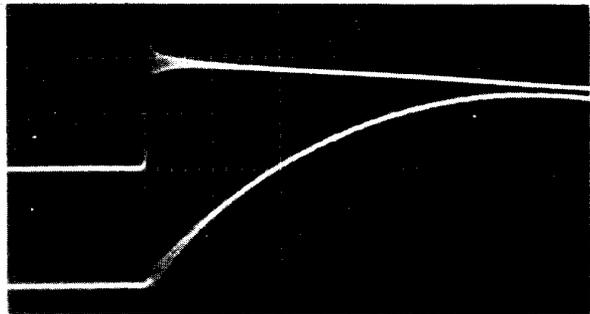
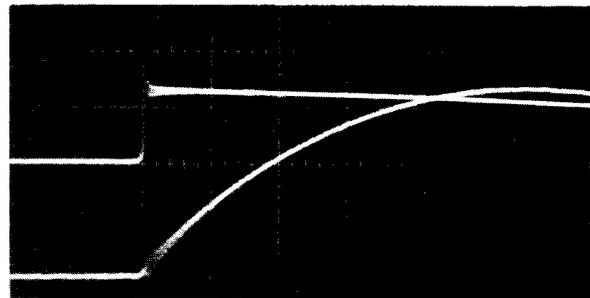
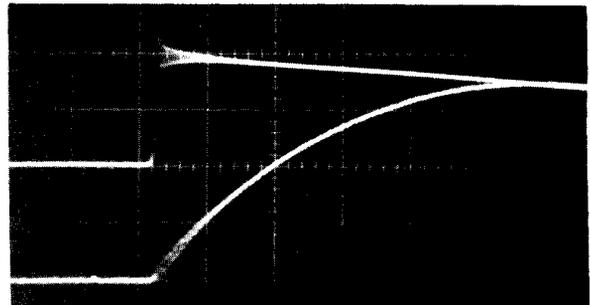
(2)
VOLTAGE ACROSS "INBOARD
SUPPRESSOR" PLUS 6"
LOOP OF WIRE

(3)
VOLTAGE ACROSS SAME
SUPPRESSOR AS (1) BUT
18" LOOP OF WIRE

Test Condition: Laboratory bench, not house simulation.

Current injection in the two suppressors
connected in series: 2.7 kA.

(To remove any doubt on a possible difference caused by a difference in disc characteristics, the separate test discussed in conjunction with Figure 16 was performed, showing that indeed the additional voltage is attributable to lead length.)

The oscillograms of Figures 13 and 15 show a difference in the performance of the outboard and inboard protectors. These two protectors, although identical for the disc size (32 mm), used discs from different production lots with potentially different characteristics. A separate test was made to determine if lead length or disc characteristic was the cause of this difference.

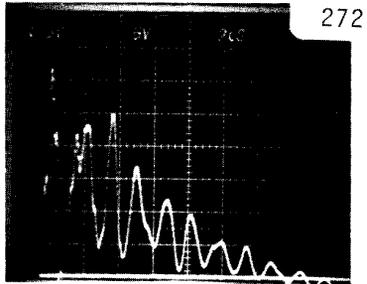
Figure 17. Voltages at Load Center with VSP-1 and "100 W load," at Remote Outlets, No Protector at Load Center

VOLTAGE AT BUS #2
(1) VSP-1 and "100 W" at B-160
(1) VSP-1 at B-80
(Outlet Sparking Over at B-40)
Voltage Across Bus:
1000 V/div

VOLTAGE AT BUS #1
(1) VSP-1 at B-160
(1) VSP-1 and "100 W" at B-80
Voltage Across Bus:
1000 V/div

Test Condition: Injected current 10 kA.
All sweeps: 2 μ s/div.

Oscillogram 272 shows that, with no relief produced by wiring flashover, the voltage envelope decays, becoming similar to that observed at lower current injection (Figure 14). However, as indicated in Oscillogram 271, flashover of the wiring (in this case the B-40 outlet) limited the voltage but not until a first crest of 7 kV had occurred and consequently started propagating in all branches of the system.
