Using Incandescent Lamp Failure Levels for Assessment of the Surge Environment

Hubert Bachl
Cooperative Testing Institute
Vienna, Austria

François Martzloff
National Institute of Standards and Technology
Gaithersburg MD 20899 USA
f.martzloff@ieee.org

Reprinted, with permission, from
Proceedings, 12th International Zürich Symposium on Electromagnetic Compatibility, 1997

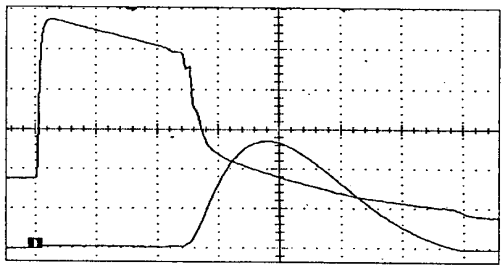
Figures 1, 2, 3, and 4 present oscillograms of the voltage across an energized 120-V bulb and of the current flowing in the bulb. Figure 1 shows a narrow window, commensurate with the duration of the surge delivered by a 1.2/50 - 8/20 µs surge generator. We observe the chopping of the voltage wave, typical of a gap sparkover, and the rise of the surge current after the sparkover. The scale of the current trace selected to record the surge (hundreds of amperes) does not show the normal current (1 A) in the bulb.[1] Observations during this test include hearing a pinging noise and seeing a bright flash of light, followed by darkness. After the test, the filament can be seen broken at one or both its points of attachment to the supporting connecting stems.

Figure 1: Voltage and current in bulb during application of a 1.2/50 µs - 8/20 µs surge, resulting in surge sparkover

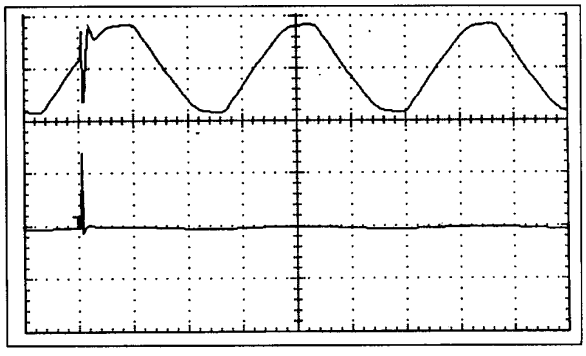
Figure 2: Voltage and current in bulb during application of a 1.2/50 - 8/20 µs surge at 30°, with surge sparkover but no power-frequency flashover

Figure 2 was recorded (with a new bulb) with a longer window than Figure 1, so as to display three full cycles of the power frequency. At that sweep rate, the surge is no longer resolved, and its apparent peak shown on the trace may be lower than the actual peak because not enough data samples are collected around the peak. However, the timing of the surge, not its amplitude is what is important in this figure. The surge event appears as a voltage spike and a current spike, followed by return to practically normal voltage and no visible large power-frequency current.

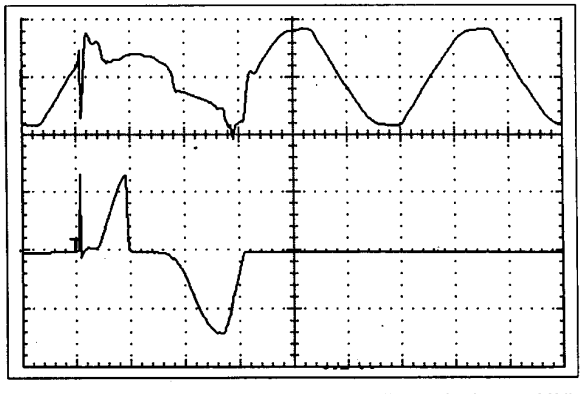
Figure 3 shows for the same bulb as that of Figure 2 the events during a subsequent shot under the same conditions. At first, after the surge, the pattern is identical to Figure 2. Then, suddenly, a pulse of power-frequency current appears, with a large amplitude -- the source of the observed flash. We believe that it is this current that causes the burn-out of the filament, not the "trigger" surge. The randomness of the process of igniting the power arc is such that in the case of Figure 2, the power arc was not ignited, while in the subsequent surge application on the same bulb (Figure 3) and in the same conditions, the power arc was ignited, resulting in burn-out of the filament -- a threshold situation.

Figure 3: Voltage and current in bulb during application of a 1.2/50 - 8/20 µs surge at 30°, resulting in surge sparkover, with delayed two-pulse power-frequency flashover

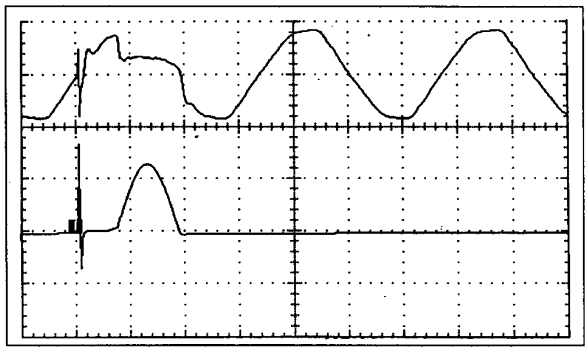
Figure 4: Voltage and current in bulb during application of a 1.2/50 - 8/20 µs surge at 0°, with surge sparkover and delayed single-pulse power-frequency flashover

As further evidence, Figure 4 shows the process (in a new bulb) when the surge was applied at 0°, requiring more energy for ultimately igniting the power-frequency flashover. At zero degrees, there is the least power-frequency voltage to ignite a power arc. Figure 4 shows the last of a seven-shot sequence in which the first applied surge had an amplitude of 1200 V. The applied surge was then raised in 100-V steps to 1500 V, still with pinging heard but no fatal power-frequency arc. To explore the hypothesis that the filament might be burned out by the surge energy, we held the surge at 1500 V for the next three shots. Only the last of the three triggered the fatal flashover, recorded in Figure 4. At that level of energy deposited by the surge, enough plasma was generated in the path of the surge current to eventually ignite the power-frequency arc, but for that shot it had to wait until the power-frequency voltage had reached its peak, again indicating a threshold situation.

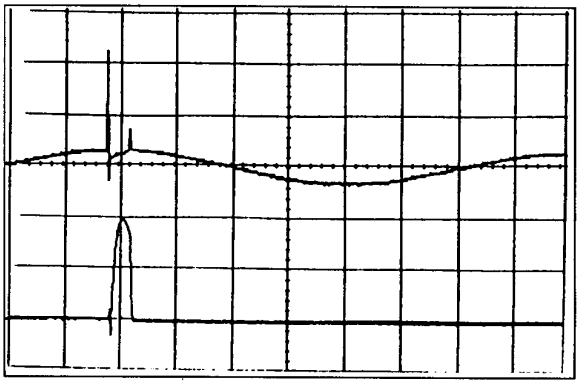
In Figure 5, a 230-V bulb shows the occurrence of a single-pulse of power-frequency flashover occurring immediately after the surge sparkover. Figures 6 and 7 show the occurrence of a delayed flashover with a single or double pulse, similar to the pattern for 120-V bulbs, respectively in Figures 4 and 3.

Figure 5: Voltage and current in 230-V bulb during application of a 1.2/50 µs - 8/20 µs surge at 90°. Surge sparkover is followed immediately by power-frequency flashover

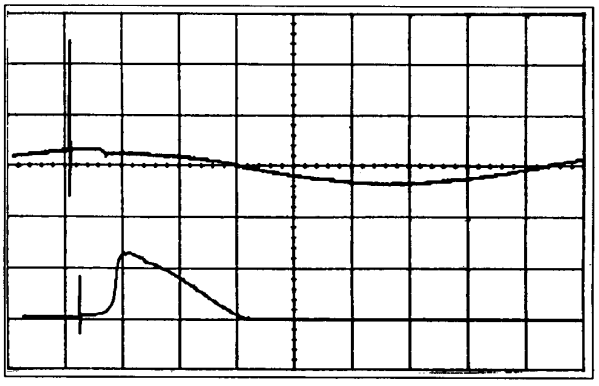
Figure 6: Voltage and current in 120-V bulb during application of a 1.2/50 µs - 8/20 µs surge at 90°. Surge sparkover and delayed one-pulse power-frequency flashover

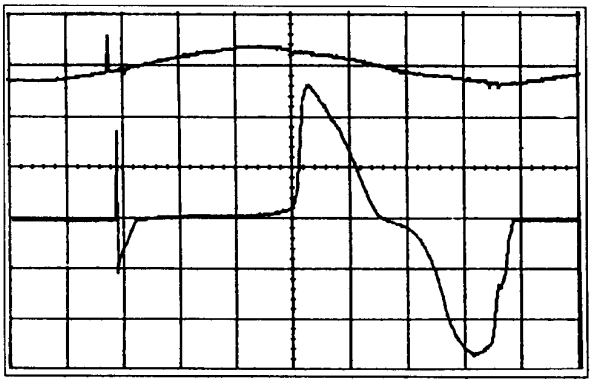
Figure 7: Voltage and current in 120-V bulb during application of a 1.2/50 µs - 8/20 µs surge at 350°. Surge sparkover and delayed two-pulse power-frequency flashover

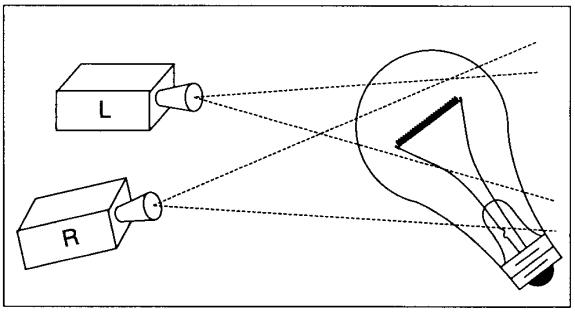
Figure 8: Arrangement of image converters to scan sparkover and flashover limited to the filament (L) and a full frame (R) including the base where the fuse is located

Figure 8 shows the arrangement of the two converters, with the left converter (L) controlled to perform four scans limited to the filament area, and the right (R) converter controlled to perform a full-frame view of the filament and fuse contained in the base stem of the bulb. The recording system was triggered by a signal from the surge generator, providing the beginning of the recording a few milliseconds before the surge, and lasting about 100 ms after the surge.

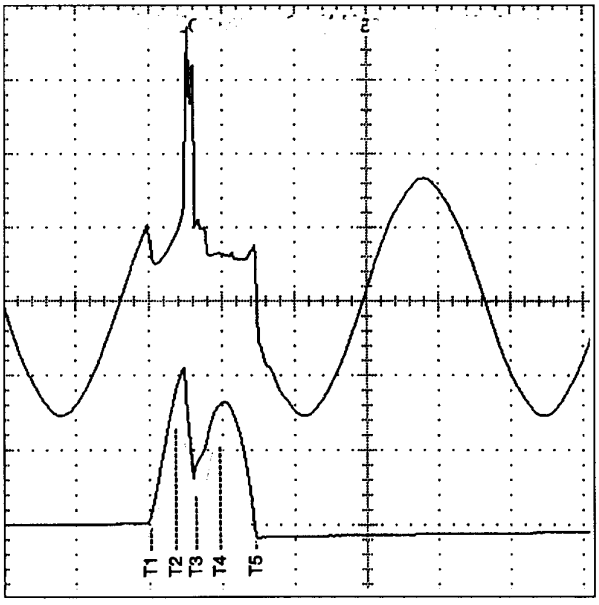
With this arrangement, recordings such as those shown in Figure 9 and Figure 10 were obtained. As an example of many oscilloscope recordings, Figure 9 shows the electrical record of the failure of a 230-V, 100-W bulb triggered by a 100 kHz Ring Wave applied 60 electrical degrees after the zero crossing. At time T1, sparkover of the filament occurs, accompanied in this case by immediate flashover of the power frequency arc, which rises to a first peak at T2, about 2.3 ms after its beginning. At that time, the current is throttled while the voltage increases sharply, indicating operation of the fuse. The fuse does not force a current zero at time T3, but allows a second peak of current at time T4, before decaying to a natural current zero at time T5.

Figure 9: Failure of a 230-V, 100-W bulb triggered by a 100 kHz Ring Wave applied at 30°, showing fuse operation

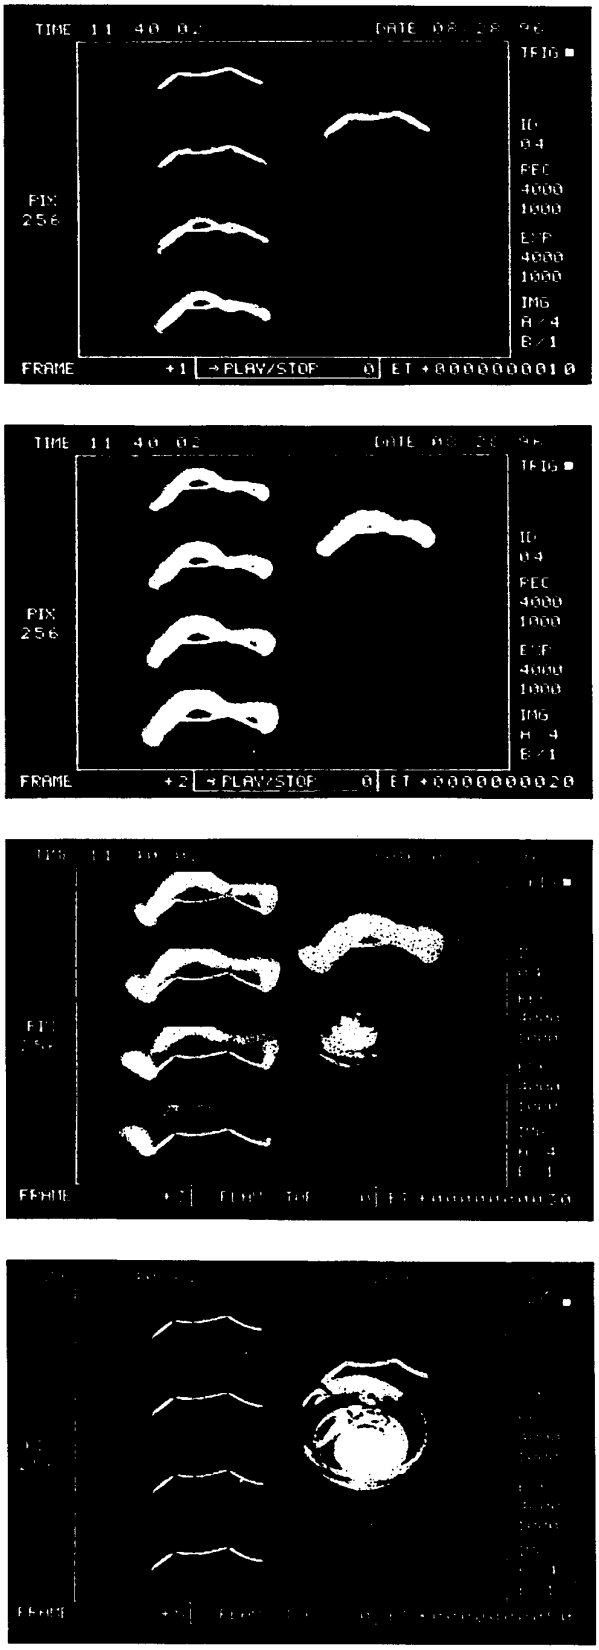
In the first frame, 0-1 ms, the Ring Wave sparkover is not visible because of its relatively low intensity/duration. The first 250-µs scan (top) of the left side shows only the filament glow. Starting with the second scan, the beginning of the flashover (time T1 in Figure 9) is visible, while the right side scan, adjusted for less sensitivity, only shows the filament glow without the flashover beginning.

In the second frame, the flashover growth is visible on the four left scans (T1-T2 in Figure 9), while the right scan now has enough light integrated over the full 1 ms time to show the flashover.

In the third frame, the first two (top) left scans still show the flashover around the filament, but the last two (bottom) scans show the flashover current being starved as the fuse in the lamp base begins to operate and transfers the current to the space around the fuse. This corresponds to the time T2-T3 in Figure 9. The right side scan shows the beginning of the glow in the base of the lamp as the current around the fuse grows.

In the fourth frame, the four left scans show the filament still glowing, ***but unchanged (not yet broken)***, while the right scan shows the integrated glow of the fuse operation, corresponding to the time interval T4-T5 of Figure 9.

These four frames, typical of many others recorded during our experiments, clearly show the mechanism of a flashover at the power-frequency current, and in this particular test sequence, the operation of the fuse in the base of the bulb. Other records taken with different light sensitivity show an intense glow near the connection of the filament, where the arc is concentrated at its point of attachment (the cathode hot spot) while the path around the filament is more diffuse. The concentrated heat near the point of attachment eventually causes a local melting of the filament. In other records, the filament is then seen separating from the stem and slowly falling in the time frame of about 20-50 ms after the flashover.

Figure 10: Sequence of flashover and fuse operation corresponding to the oscillogram of Figure 9
