Semiconductor Performance
under Reverse Transient Overvoltages

François Martzloff
General Electric Company

AUTHOR	SUBJECT	NO.
Martzloff, FD	semiconductors and transients	67-C-066
		DATE March 1967

TITLE Semiconductor Performance under Reverse Transient Overvoltages	G.E. CLASS 2
	GOVT. CLASS -

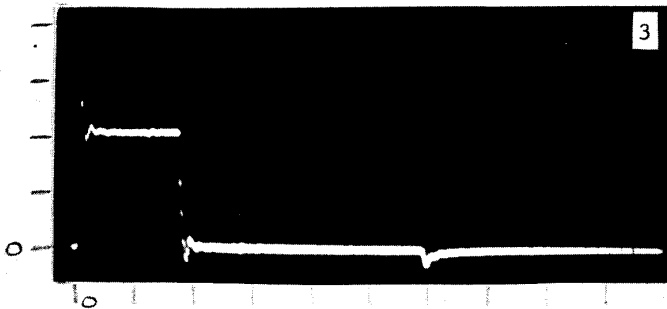
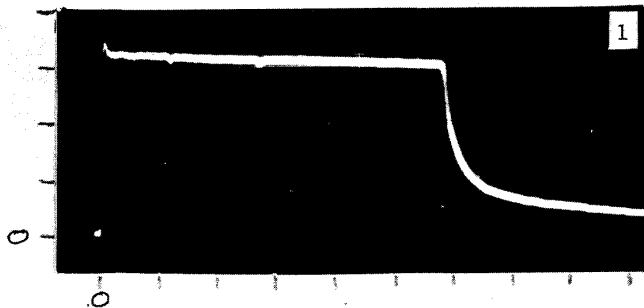
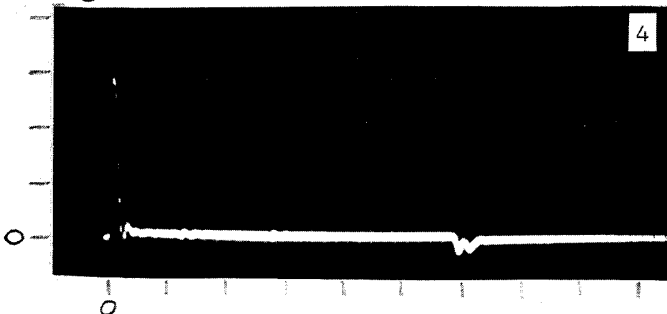
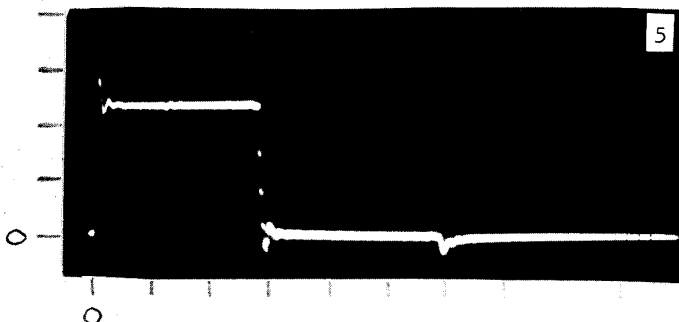
Failure of a C20A SCR in 3.8 μs,
while voltage was clamped at
1050 volts.

Failure of a C20D SCR in 2 μs,
while voltage was clamped at
1000 volts.

Failure of a C20D SCR in 0.1 μs,
before avalanche could produce
any voltage clamping.

Failure of a C20A SCR (aged by high
temperature storage) in 3 μs, while
voltage was clamped at 1200 volts.

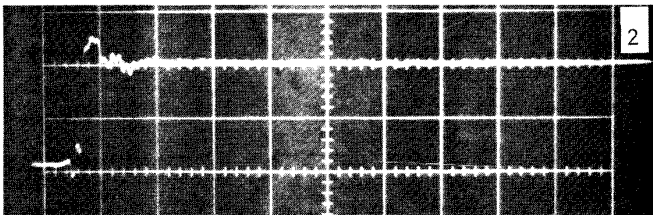
Failure of C20A SCR with forward
current in 3.5 μs
Top: 500 volts/div.
Bottom: 40 amp/div.
Sweep: 1 μs/cm
Available pulse length 6 μs

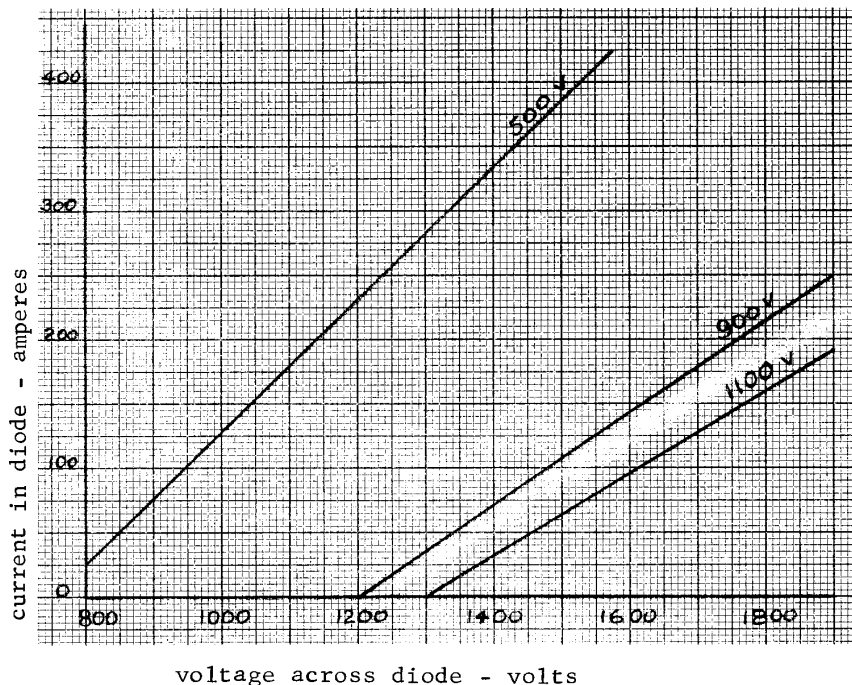
Avalanche characteristics

of 500, 900, & 1100 volts
A92 test samples

The test points for one device fell on an approximately straight line with linear volt and ampere scale (see Figure 1). Furthermore, the lines for a group of devices graded in the same voltage class lie within a 100 volt band and run parallel; only one has been drawn in Figure 1 in the case of the 500 volt characteristic which corresponds to three test samples. The slope of the 500 volt rectifiers on one hand and 900 and 1100 on the other hand are different, corresponding to constant dynamic resistance of 1.6 and 2.6 ohms respectively.

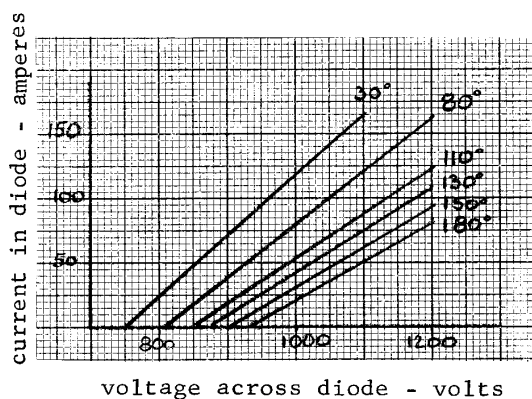
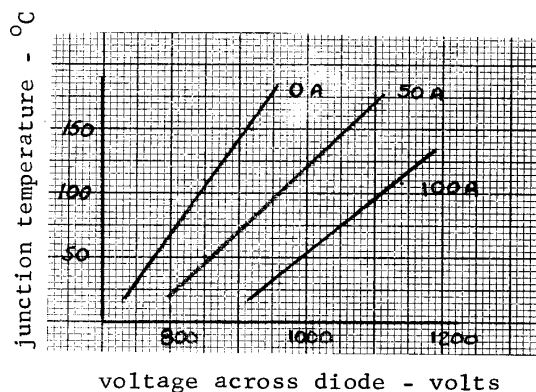
Figure 2
Avalanche characteristics of a
500 volt diode, measured at

start of pulse, with junction

at the initial temperature shown

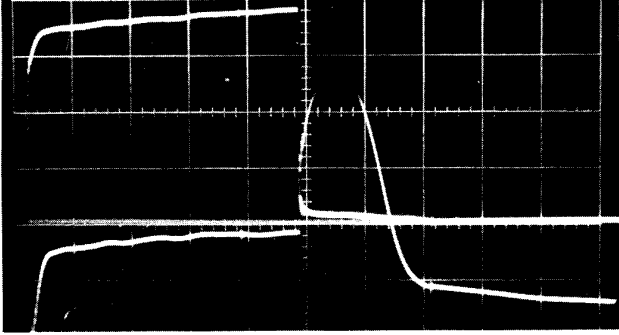
Failure of 1100 volts unit at
1900 volts, arc across varnish
Test at 30°C ambient

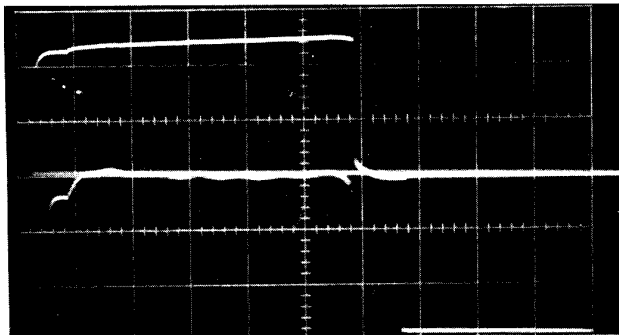
Failure of 500 volts unit at
1400 volts, arc at upper PP$^+$
junction due to field pinch
Test at 150°C ambient

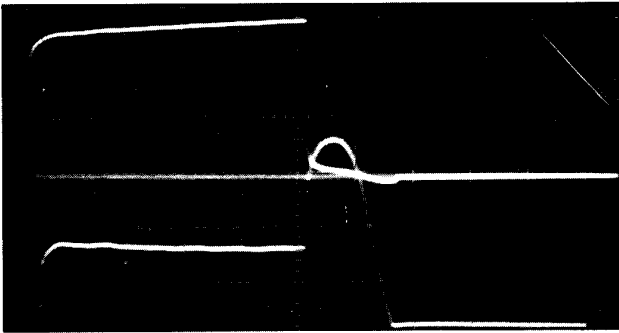
Failure of 500 volts unit at
1250 volts, bulk failure
Test at 150°C ambient

Bulk failure vs. Arc failure
Note how breakdown occurred as voltage had begun to decrease shortly
before end of applied pulse, in contrast with arc failure which occurred
during voltage rise.

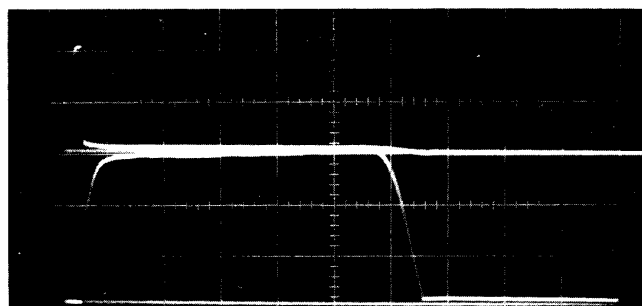
1200 volts PIV unit test at 30°C ambient

Failure at 2000 volts in 12 μs
Arc across varnish

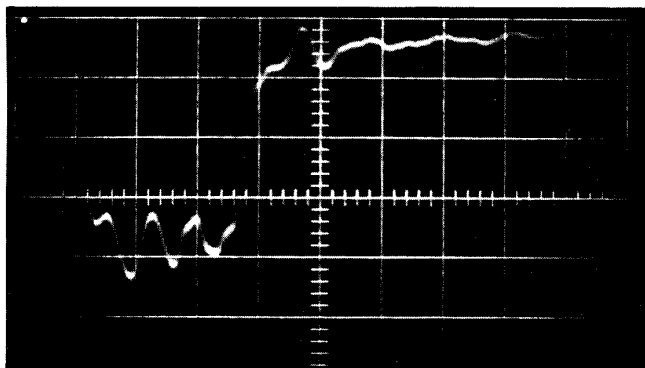
Failure of 200 volts PIV unit
same generator setting as above,
with oscillations caused by
interaction of the diode capacitance.
Failure at 1800 average volts in
250 ns
Arc across varnish

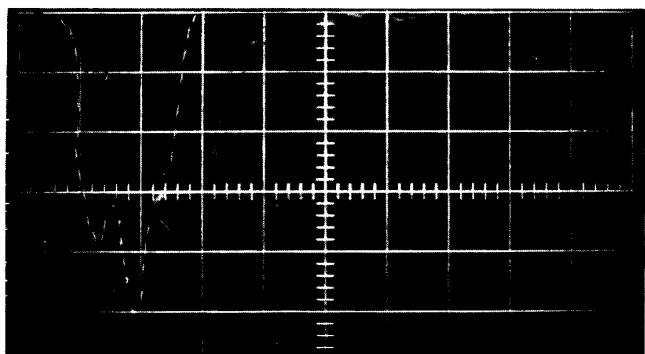
Failure of 1200 volts PIV unit
No-load generator setting 2200 volts
Failure at 1900 average volts in
200 ns
Arc across varnish
(trace indicated by scratches for
 reproduction)

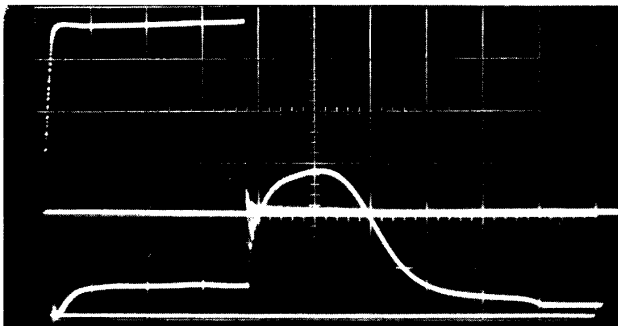
1000 volts unit

Failure at 1600 volts with low current - 10A

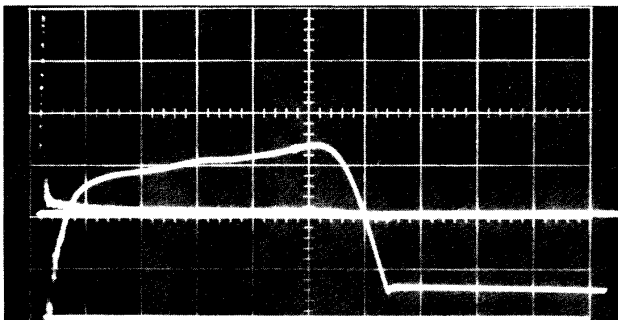
1000 volts unit

Failure at 1900 volts with high current - 300A

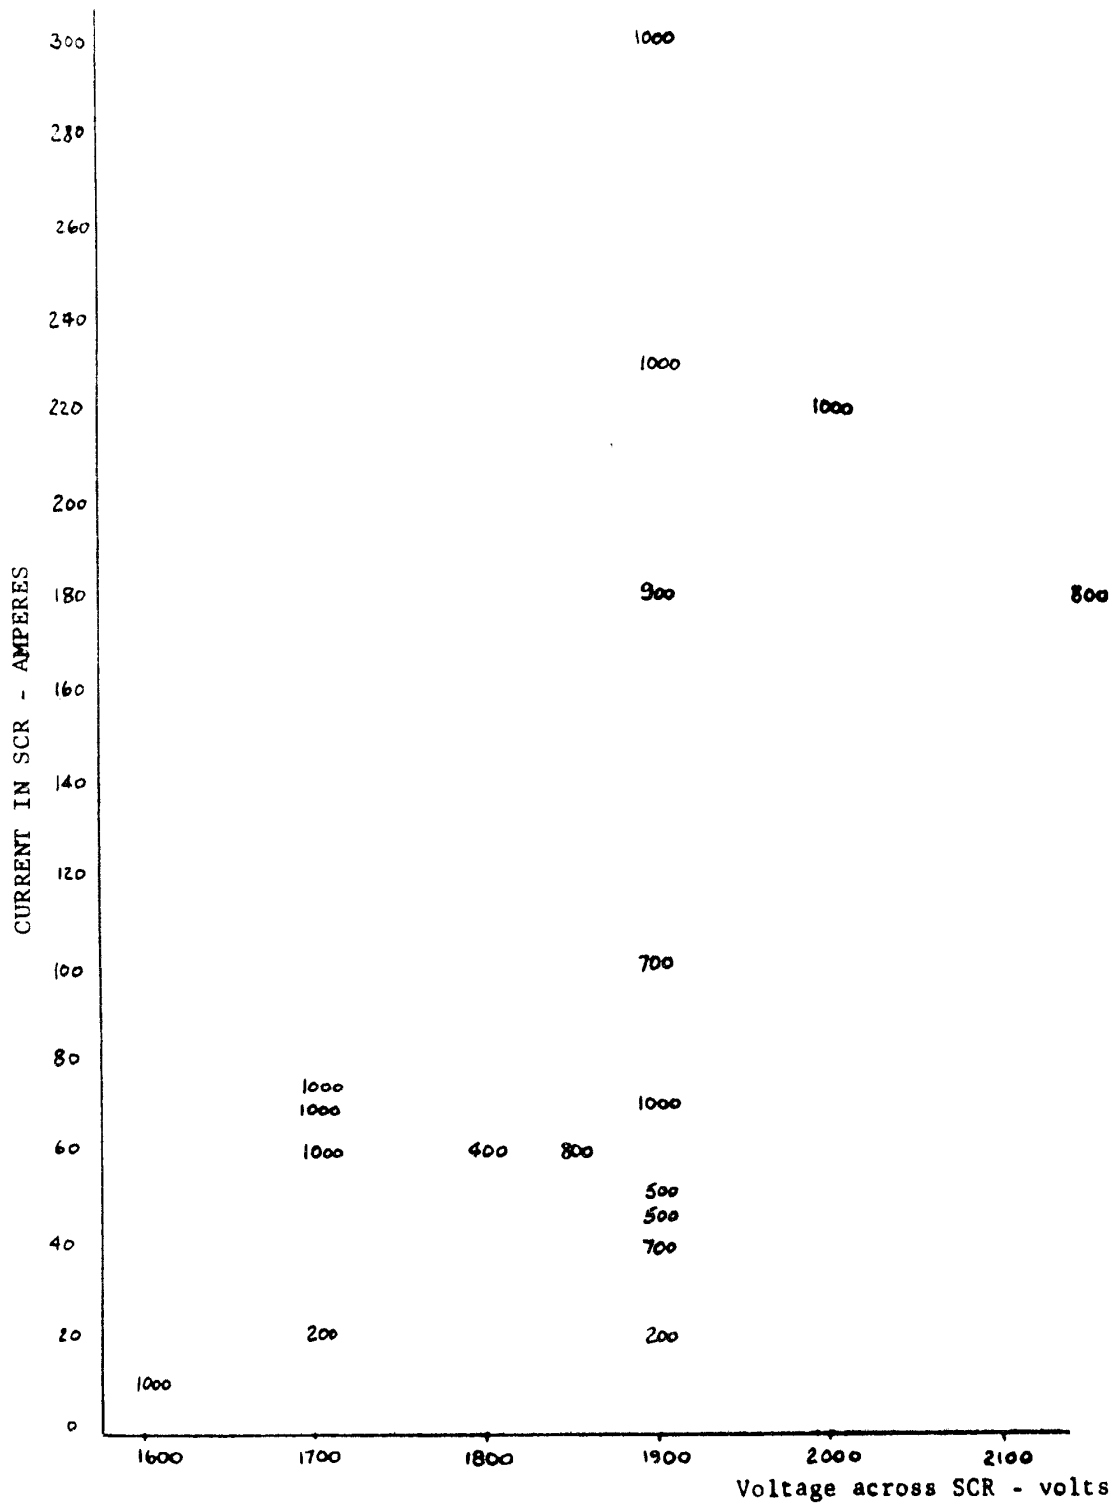
DISTRIBUTION OF FAILURE POINTS - VOLTAGE VS CURRENT FOR VOLTAGE CLASS SHOWN

Inspection of the tabulated results shows several interesting points: The voltage at failure varies between 1600 and 2100 volts, for a range of voltage class ratings from 200 to 1000 volts; there is no correlation between the voltage class on one hand and the voltage and current at failure on the other hand.

The plot shown on the opposite page was made in an attempt to correlate voltage across the SCR with the avalanche current, for a specific voltage class. The number plotted represents the voltage class while the coordinates are the voltage and current at the time of failure. There is no readily apparent correlation or trend in the location of the failure points in this plot.
