Surge Protection Anthology
All Papers – Part 3
Recorded surge occurrences, surveys and staged tests

Surge Suppression in a Typical Home Wiring System

SURGE VOLTAGES IN RESIDENTIAL POWER CIRCUITS

SURGE VOLTAGES IN RESIDENTIAL AND INDUSTRIAL POWER CIRCUITS

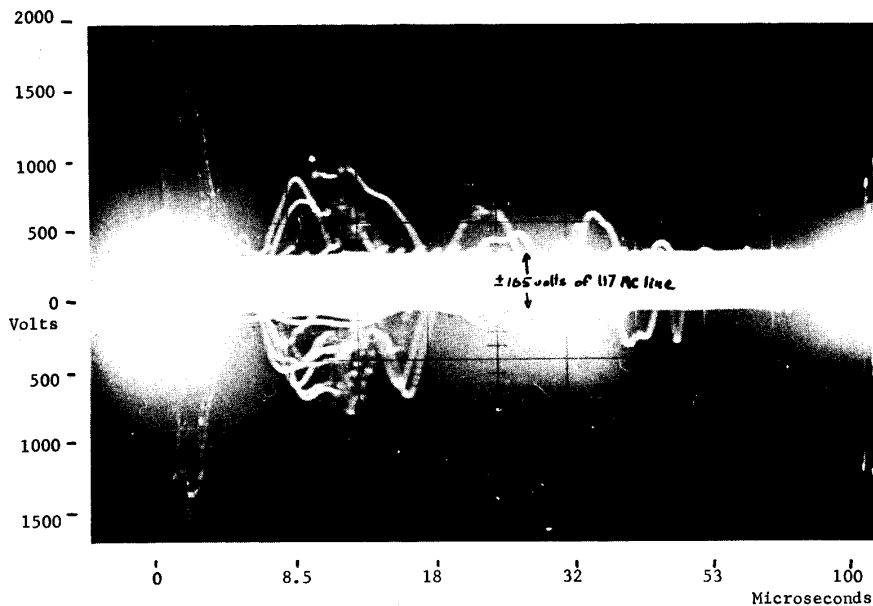
Composite record showing surges for a 24-hour period.

Oscilloscope is triggered for each surge, plus once every hour, resulting in $\pm$ 165 volt band of steady-state 60 cps voltage.

Recordings above 1800V are blanked out by oscilloscope.

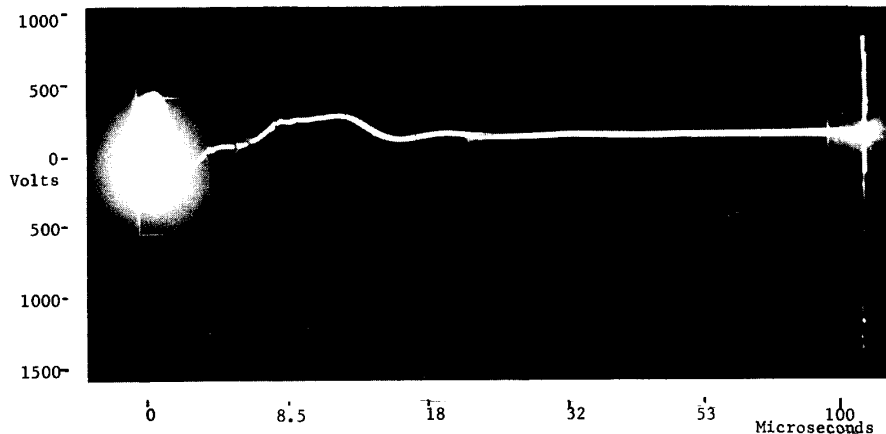
Single surge occurring 150 μs after initial, low amplitude surge triggered the oscilloscope.

Cause not determined.

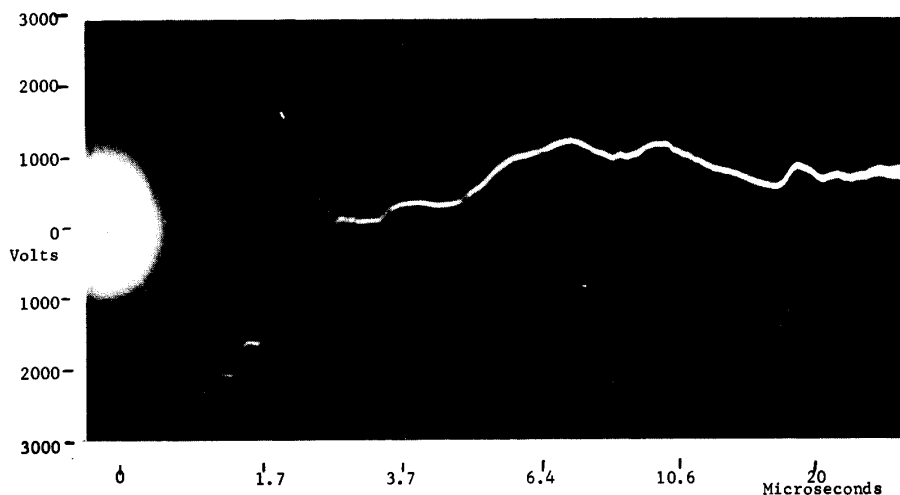
Maximum recorded surge, at 2600 volts.

In a 5-day period surges of this wave shape were recorded as follows:

Cause: H.V. transformer for oil furnace interrup

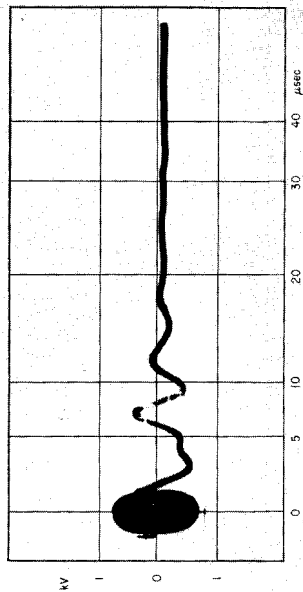
Figure 7a. Internal Switching Transient Recorded at a Farmhouse (15 such transient surges in 1500 hours)

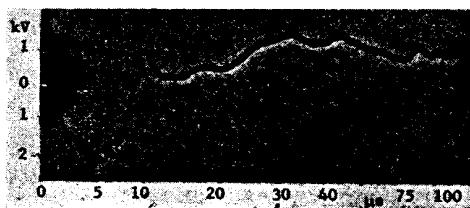
Fig. 7. Residential surge, oil burner ignition.

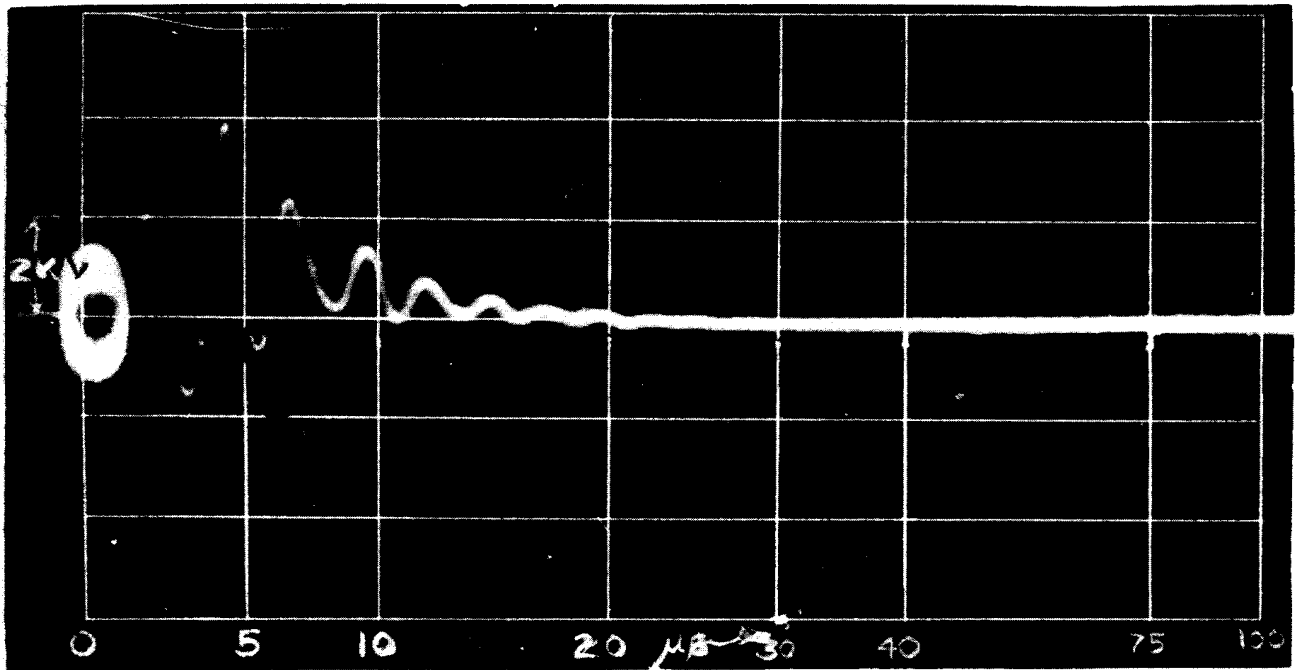
Lightning surge at Deer Park   3.8 KV crest, 1μs rise time
330 KC oscillation

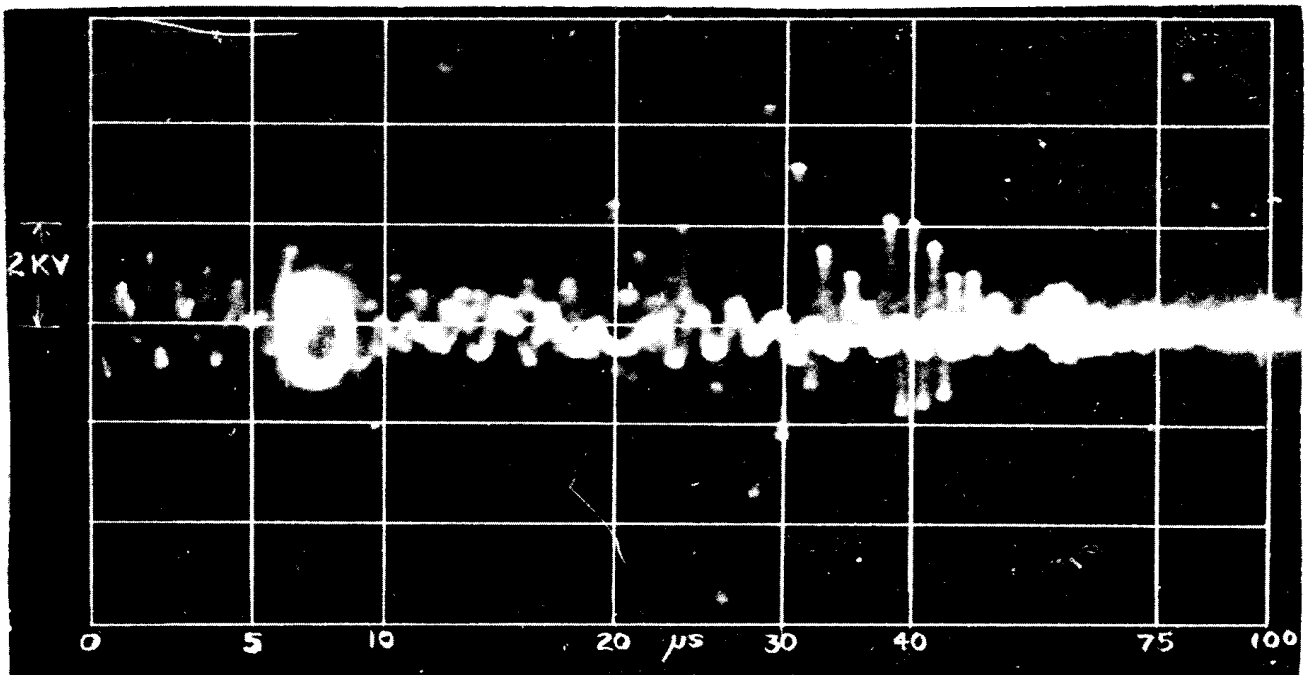
Lightning surge at Deer Park   5.6 KV crest, rise time < 1μs
500 KC oscillation

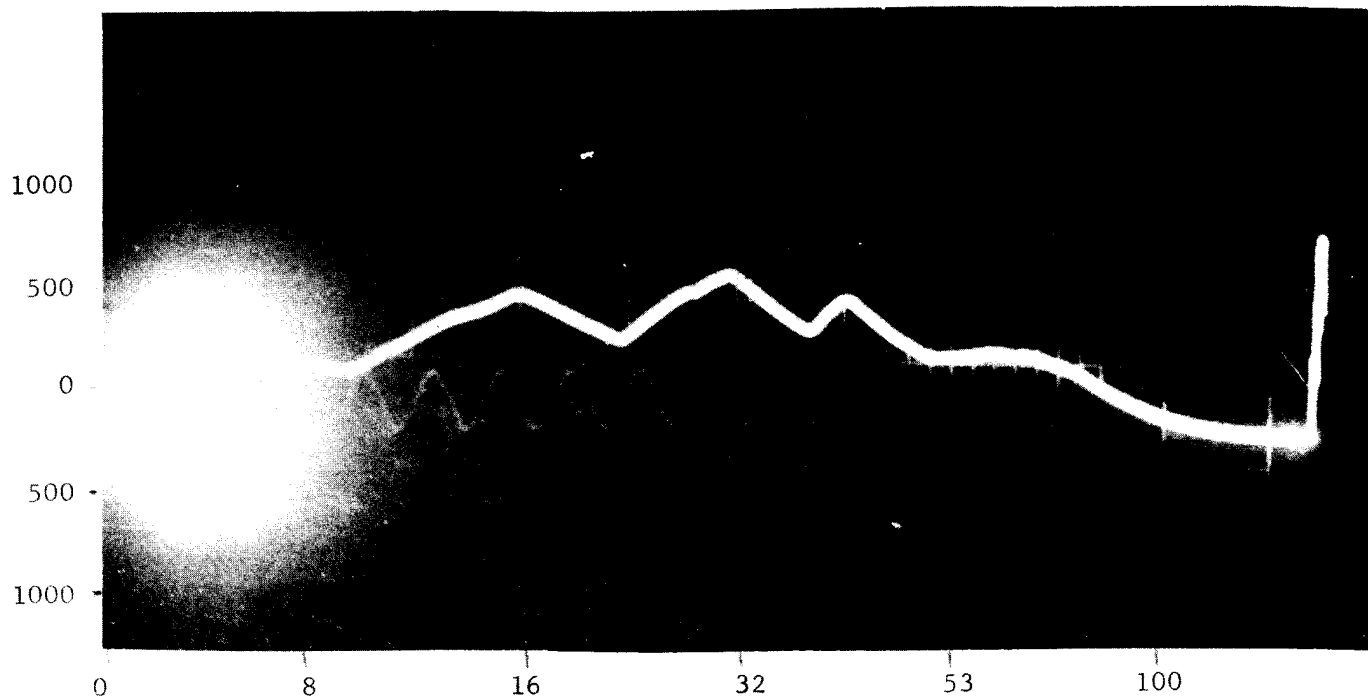
Switching transient with restrikes--probably external to the house.
(The faint sine wave corresponds to the return of the electron beam which was
not completely blanked out. It illustrates the peak-to-peak value of the
steady state 117 voltage, but not at the same rate as the forward sweep.)

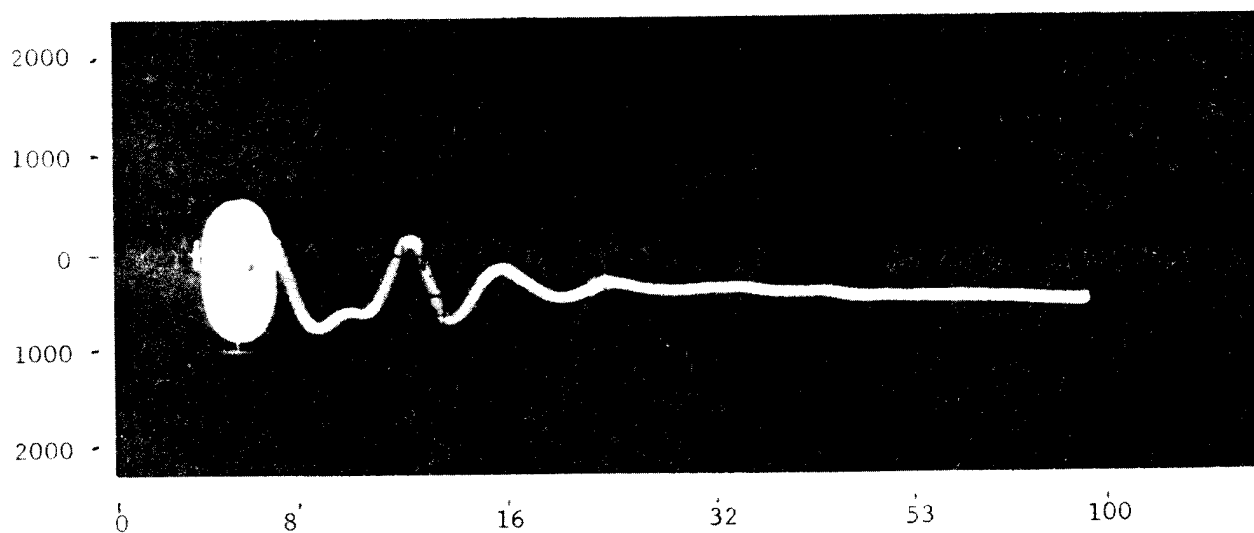
Internal switching transient
(15 such transients in 1500 hours)

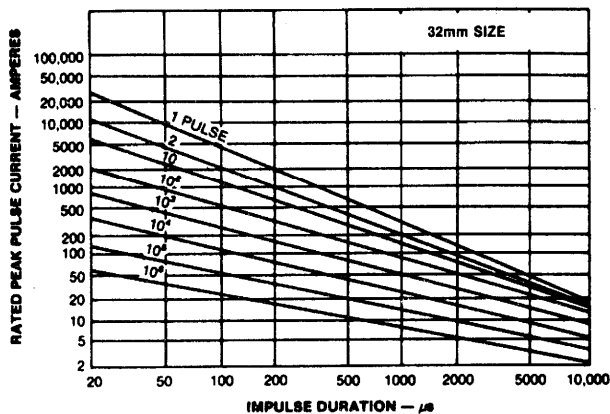
Figure 8.   Pulse ratings of 32 mm varistor [5]

Figure 8 shows the same curves for a proposed 32 mm varistor. It should be noted that the pulse rating does not mean catastrophic failure of the varistor at the end of this rating, but only a 10% change in the varistor nominal voltage. Although some change is indicated, the varistor is quite capable of staying on line voltage and of clamping surges.

An obvious remedy would be to use a varistor with greater energy-handling capability. The 32 mm size offers such a possibility. Inspection of Figures 7 and 8 shows that the equivalent pulse of Figure 10 (800 μs and 100 A) corresponds to a permissible occurrence of 100 pulses for the 32 mm varistor, in contrast to the two for the 20 mm varistor. The improvement in the number of pulses is 50 times more pulses until *pulse rating* is reached. The improvement in the number of pulses until *varistor failure* occurs, however, is not necessarily 50 times more pulses. Because of the imprecision mentioned previously in the margin between end of pulse rating and ultimate failure, that margin is not necessarily the same for the two sizes, 20 mm and 32 mm, but it is reasonable to expect the same order of magnitude improvement in the ultimate failure as in the pulse rating. This expectation of a 50 times improvement would change the time between failures from the few days observed with the 20 mm size to perhaps one year with the 32 mm size, providing immediate relief and time to make further changes for the long term. Therefore, the change to a 32 mm size, connected at the same point of the circuit, was immediately implemented for that particular environment.

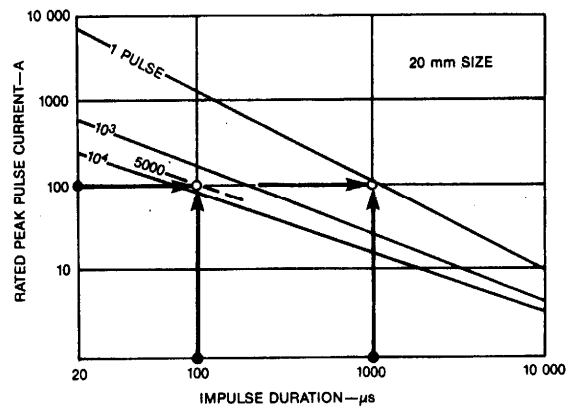
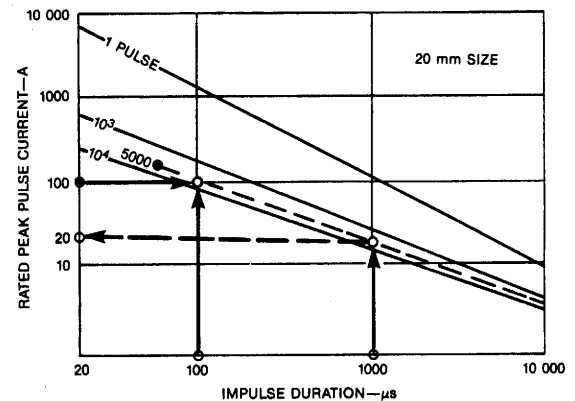
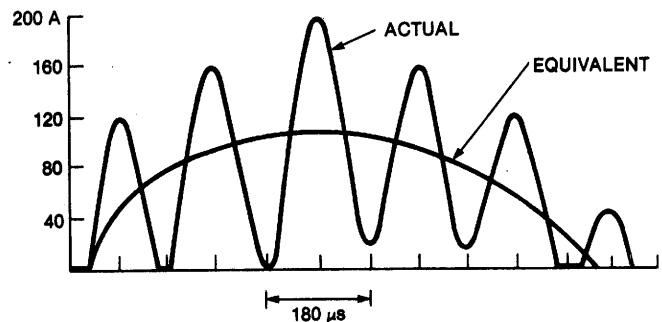
Figure 10.   Single-pulse equivalent pulse for multiple pulses

The equivalent pulse of Figure 10 can then be used to evaluate, from the pulse ratings of Figure 7, the number of high-amplitude switching transients that will consume 100% of the varistor pulse rating. Inspection of Figure 6 shows that for a 800 μs duration and 100 A amplitude, the pulse rating of the 20 mm varistor (6 kA rating at 8/20 μs) is reached with two such events. With a probability of about 10% that this highest switching transient would occur during random timing of the switching (the effect decreases rapidly for transients other than the highest) and with 2 to 4 switching operations each day, the pulse rating of the varistors could be reached with 20 operations, failure perhaps starting at 40 to 50 operations, or after about 10 days of exposure to that power system environment. This estimate is unavoidably imprecise because the pulse rating curves represent a conservative minimum; actual failures will occur only for amplitudes or numbers of pulses exceeding the rating by a large but imprecise margin to allow for manufacturing variations. However, the order of magnitude of this estimated time to failure is in accord with the observations made at that installation.

Note that two types of events occur. One is the premature blowing of the fuse, which is not caused by a varistor failure but by the i^2·t capacity of the fuse being exceeded by the environment [1]. The other is the fuse blowing caused by the varistor end-of-life ultimate failure.

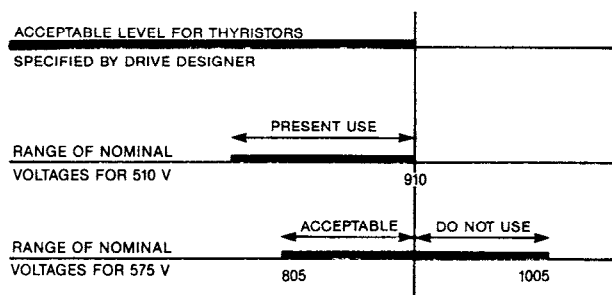
Figure 11.   Tolerances bands of 510 V and 575 V varistors

Of course, the standard varistor product line has a certain tolerance band, reflecting normal production lot variations. In principle, a selection could be requested from the manufacturer that varistors with a narrower band be supplied for this application. The maximum clamping voltage allowed by the drive specifications would be retained, but those varistors in the lower half of the distribution, which draw larger current pulses for a given open-circuit transient voltage, would have been removed from the population of varistors. For instance, the range of nominal voltages for a 575 V, 32 mm varistor (the next higher voltage offered) is 805 to 1005 V for 1 mA dc, while the maximum nominal voltage of the same diameter but rated 510 V is 910 V for 1 mA dc. Thus, for a normal distribution of nominal voltages of the 575 V varistor, 50% of the devices could theoretically be used without exceeding the upper limit of the 510 V varistor that is consistent with the drive specifications. To achieve this end, it would be necessary for the supplier or user to make a careful determination of the nominal voltage on a population of 575 V varistors in order to retain only the lower half of the distribution (Figure 11).

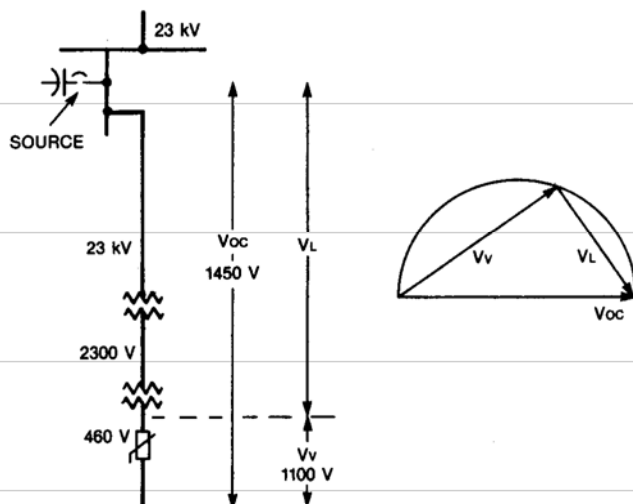
Figure 12.   Open-circuit voltage and voltage drops in the system

Furthermore, the 5700 V clamping level predicted for the 2300 V surge arresters at 60 A would be reflected as a crest of 5700 V × 460/2300 = 1140 V on the 460 V side. The 510 V, 32 mm varistors, connected in series with the impedance of the 2300/460 V transformer, would then be exposed to this maximum

open-circuit voltage of 1140 V, a value much lower than the 1450 V open-circuit voltage that was applied to them in the absence of the 2300 V arresters. For that applied voltage, the current drawn by the varistor would be in the range of 10 to 20 A, values much lower than the 200 A measured without the 2300 V arrester. Computing the equivalent pulse, as was done in Figure 10 for the 200 A crests, would yield an equivalent crest of about 10 A, for which the pulse rating curves of the 32 mm series show more than 100,000 pulses before its rating is reached.

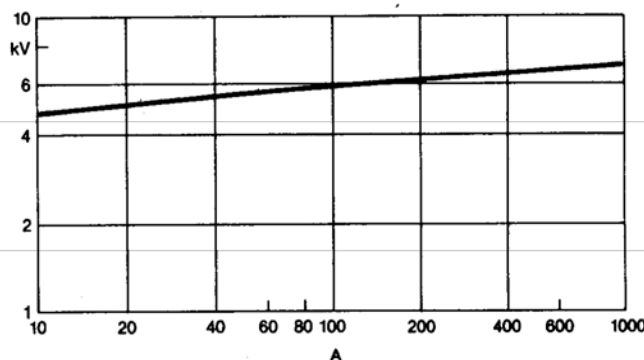
Figure 13.   Minimum clamping voltage characteristic for 2300 V arrester

a) Assume a current crest of 50 A, producing a drop of 50 × 75 = 3750 V in the line and 23,000/2300 V transformer. Adding this voltage to the varistor voltage, corresponding to 50 A, which is read as about 5700 V on the arrester characteristic curve for minimum discharge voltage (Figure 13), we have $(3750^2 + 5700^2)^{1/2} = 6780 \text{ V}$, or somewhat below the expected 7250 V open-circuit voltage, which is to equal the quadratic sum of the two voltages V_L and V_V.
