Varistor versus Environment: Winning the Rematch

VARISTOR VERSUS ENVIRONMENT: WINNING THE REMATCH

François D. Martzloff, Fellow IEEE
Corporate Research and Development
General Electric Company
Schenectady, New York 12345

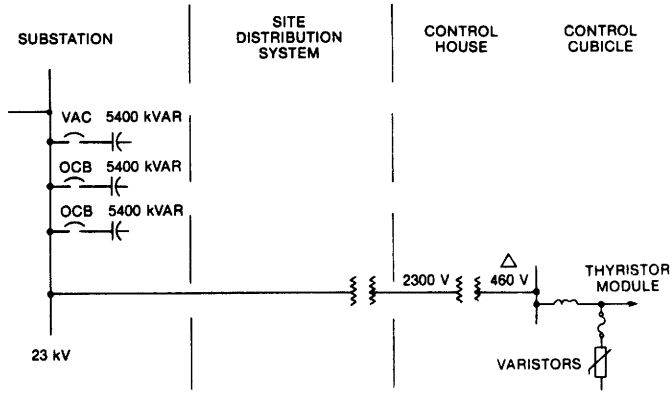
Figure 1. Simplified one-line diagram

Figure 1 is a simplified one-line diagram of the significant elements of the power system causing the varistor failures. The incoming 115 kV power is stepped down to 23 kV. Three banks of 5400 kVAR capacitors are connected to the 23 kV bus. Typical operating conditions involve two banks connected at all times, with the third bank switched on or off automatically to provide voltage regulation. Power distribution throughout the site is done at the 23 kV level.

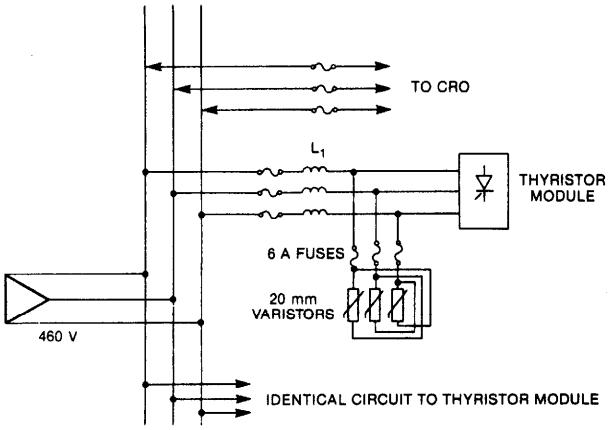
Figure 2. Simplified three-phase schematic

Figure 2 is a simplified three-phase schematic of the power input. In the original circuit, the thyristor modules were protected by varistors at the power input of the 1250 hp drive, where the measurements were made. A 6 μH line inductance, L1, was inserted between the bus and the thyristor modules; 20 mm varistors rated 510 V were connected in a delta configuration, in series with a current-limiting fuse in each line. The varistor connection was about 80 cm long, introducing an estimated 1 μH inductance into each lead.

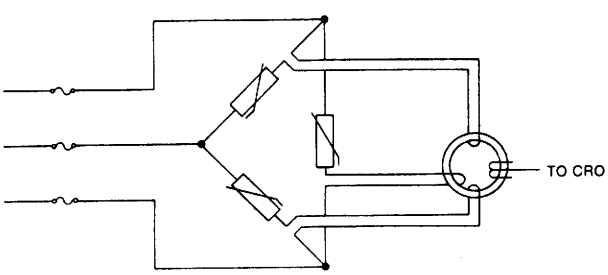
Figure 3. CT connection for recording all three varistor currents

Manual off-on switching of the 5400 kVAR capacitor bank at the 23 kV utility substation was the next step in the measurement procedures because the switching of a capacitor bank is always a prime suspect for producing transients. Measurements were performed with one oscilloscope monitoring the line voltage upstream of the line inductors (Figure 2) and another oscilloscope monitoring the sum of the currents in the three varistors (Figure 3).

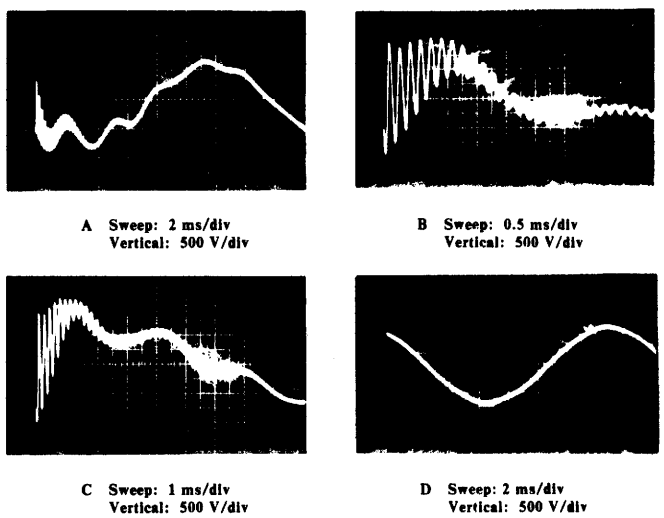
Figure 4. Capacitor switching transients and steady-state voltage

The oscillograms of Figure 4 show typical voltage recordings made during this sequence. The voltages are *not* open-circuit transient voltages. They are instances of the voltage appearing at the bus entrance point. This voltage is the sum of the varistor clamping voltage, the voltage drop in the varistor connections, and the voltage across two L1 inductances.

A typical total event recorded on one of the phases during a capacitor bank closing is shown in Figure 4A. A low-frequency oscillation with a period of 3 ms (330 Hz) and initial peak-to-peak amplitude of 450 V decayed in about 10 ms. The high-frequency oscillations are resolved in the recording of Figure 4B (recorded during a similar switching sequence). This high frequency has an initial peak-to-peak amplitude of 2000 V, decaying in about 5 ms. The period is 180 μs (5.5 kHz). A similar, third event is shown in Figure 4C. For scaling the amplitudes, the steady-state voltage is shown in Figure 4D.

Observe that, depending on the time of closing with respect to the 60 Hz voltage, the 5.5 kHz oscillation varies in amplitude; furthermore, the modulation by the 330 Hz oscillation pushes crests of the 5.5 kHz oscillation above the 1000 V level some time after the beginning of the trace, at a time when the 5.5 kHz amplitude is already lower, producing a burst of pulses above the 1000 V level.

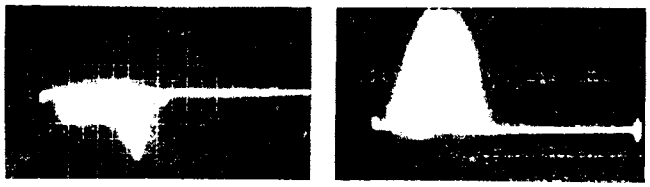
Figure 5. Current surge bursts during capacitor switching

The significance of this finding will be discussed next, with reference to Figure 5, which shows recordings of transient currents in all of the three varistors. The 510 V varistor has a nominal voltage at 1 mA [2] in the range of 735 V to 970 V. For a varistor with a nominal voltage in the middle of this range, a current in the order of tens to hundreds of amperes will flow if a voltage of 1000 V is applied to the varistor. Figure 5A shows a train of current pulses in the range of 10 to 40 A. In the burst of Figure 5B, the recorded current pulses range from 5 A to 200 A. The current and voltage traces are not simultaneous events because each of the two oscilloscopes was triggered by its internal circuit. The nearly symmetrical appearance of this burst can be compared to the symmetry of the voltage peaks exceeding the 1000 V level in Figure 4, the one correlating with the other.

The oscillograms of Figures 4 and 5 were selected as most severe from a series of 20 capacitor switching sequences. Some sequences could not even produce a current or voltage trigger; four sequences produced bursts with the central peak exceeding 120 A, two of these reaching 200 A peaks.

These recordings establish the nature of the current surges that are conducted by the varistors, with an estimate of 10% reaching 200 A maximum crests and another 10% reaching 120 A crests, for all capacitor bank switching.

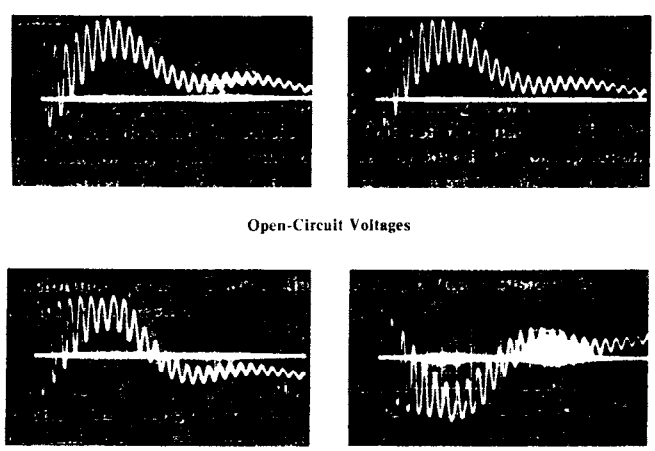
Figure 6. Capacitor switching transients

The oscillograms of Figures 4 and 5 establish and explain the pattern of current pulses. The voltages of Figure 4 are not the open-circuit voltages impinging the drive input but, rather, the voltages resulting from the clamping action of the varistors. To better evaluate the magnitude of the switching transients, open-circuit voltages were recorded in a next sequence, with all fuses to the drive open, thus disconnecting both the varistors and all sensitive loads. Figure 6 shows two typical recordings of open-circuit voltages and two of voltages resulting from varistor clamping, recorded during a series of 10 switching sequences for each condition. Table 1 shows the recorded crests of the five highest voltages in each condition; the difference between the two groups, with due allowance for the imperfect statistical basis of the observations, indicates that the 510 V varistors reduced the peaks from a typical high of 1450 V to a typical high of 1100 V.

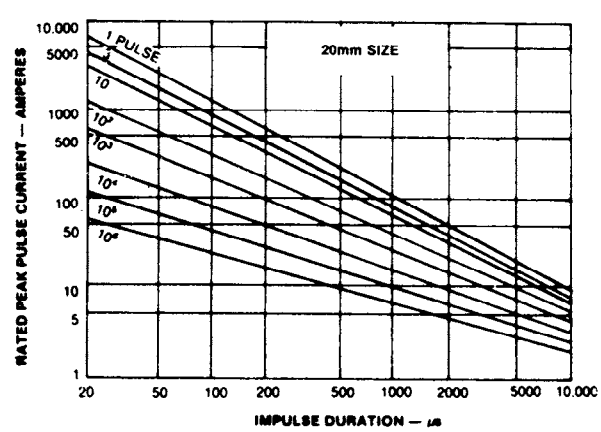
Figure 7. Pulse ratings of 20 mm varistor [4]

Published varistor specifications include the "pulse ratings," a family of curves that define, for each varistor type, the number of isolated pulses that a varistor can absorb until its "rating" is reached [4]. The curves show lines relating amplitude, duration, and total number of pulses. Figure 7 shows this family of curves for the original 20 mm varistor.

The equivalent pulse of Figure 10 can then be used to evaluate, from the pulse ratings of Figure 7, the number of high-amplitude switching transients that will consume 100% of the varistor pulse rating. Inspection of Figure 6 shows that for a 800 μs duration and 100 A amplitude, the pulse rating of the 20 mm varistor (6 kA rating at 8/20 μs) is reached with two such events. With a probability of about 10% that this highest switching transient would occur during random timing of the switching (the effect decreases rapidly for transients other than the highest) and with 2 to 4 switching operations each day, the pulse rating of the varistors could be reached with 20 operations, failure perhaps starting at 40 to 50 operations, or after about 10 days of exposure to that power system environment. This estimate is unavoidably imprecise because the pulse rating curves represent a conservative minimum; actual failures will occur only for amplitudes or numbers of pulses exceeding the rating by a large but imprecise margin to allow for manufacturing variations. However, the order of magnitude of this estimated time to failure is in accord with the observations made at that installation.

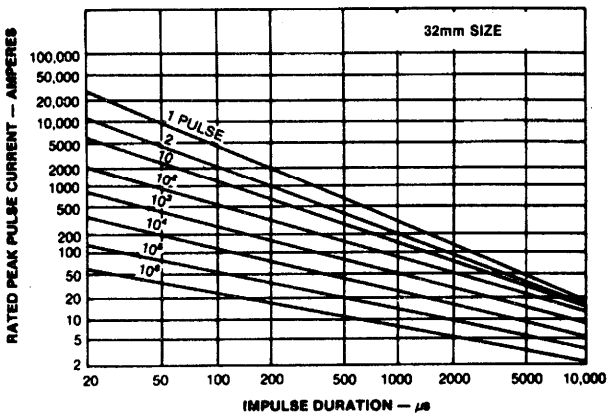
Figure 8. Pulse ratings of 32 mm varistor [5]

Figure 8 shows the same curves for a proposed 32 mm varistor. It should be noted that the pulse rating does not mean catastrophic failure of the varistor at the end of this rating, but only a 10% change in the varistor nominal voltage. Although some change is indicated, the varistor is quite capable of staying on line voltage and of clamping surges.

An obvious remedy would be to use a varistor with greater energy-handling capability. The 32 mm size offers such a possibility. Inspection of Figures 7 and 8 shows that the equivalent pulse of Figure 10 (800 μs and 100 A) corresponds to a permissible occurrence of 100 pulses for the 32 mm varistor, in contrast to the two for the 20 mm varistor. The improvement in the number of pulses is 50 times more pulses until *pulse rating* is reached. The improvement in the number of pulses until *varistor failure* occurs, however, is not necessarily 50 times more pulses. Because of the imprecision mentioned previously in the margin between end of pulse rating and ultimate failure, that margin is not necessarily the same for the two sizes, 20 mm and 32 mm, but it is reasonable to expect the same order of magnitude improvement in the ultimate failure as in the pulse rating. This expectation of a 50 times improvement would change the time between failures from the few days observed with the 20 mm size to perhaps one year with the 32 mm size, providing immediate relief and time to make further changes for the long term. Therefore, the change to a 32 mm size, connected at the same point of the circuit, was immediately implemented for that particular environment.

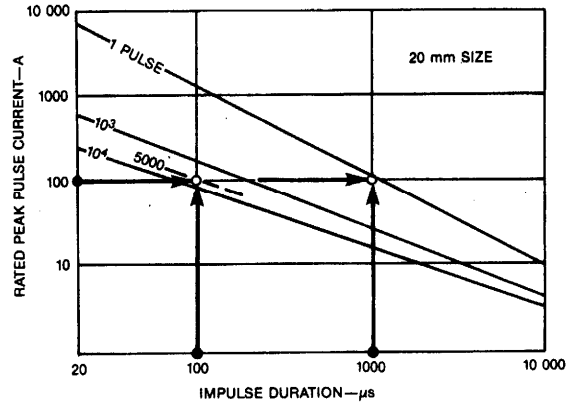
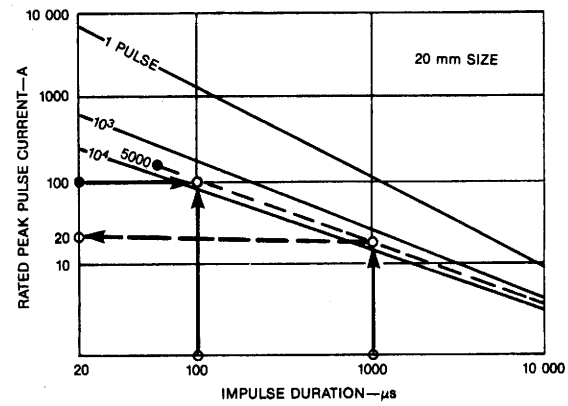
Figure 9. Reading pulse ratings curves

A careful examination of the pulse rating curves will show that the duration of the pulses has a strong influence on the number of permissible pulses. Furthermore, the relationship between the increased duration of the pulses and the decreased number of permissible pulses is not proportional. For instance, consider pulses of 100 A peak and 100 μs duration (Figure 9A): the curves show 5000 pulses allowed. Now increase the duration of the pulses to 1000 μs (a ten-fold increase), while keeping the amplitude at 100 A: the curves show the permissible number as one pulse only. Thus, the ten-fold increase in duration does not result in a ten-fold decrease in the number of permissible pulses; the reduction in that number is much greater than the inverse of the increase in duration. Conversely, taking a pulse duration of 1000 μs, and seeking the amplitude allowable for the same 5000 pulses, Figure 9B shows that the current is 20 A, which is five times less than the original 100 A, not ten times less. Therefore, it would be incorrect to treat the multiple pulses of Figure 5 as five separate short pulses; rather, one equivalent long pulse has to be defined.

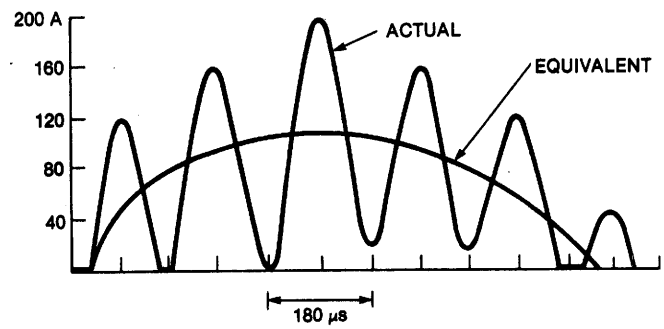
Figure 10. Single-pulse equivalent pulse for multiple pulses

The five-pulse burst of Figure 5 has been redrawn in Figure 10 in order to plot an equivalent continuous pulse of approximately equal duration, with a crest such that the i·t integral of the burst and the i·t of the equivalent pulse are approximately the same. The use of i·t rather than the $i^2 \cdot t$ integral typically used for fuses or other linear loads is justified by the fact that heat deposited in the varistors is the significant parameter because the nominal voltage change process is temperature related; this heat is the product of the variable i and the nearly constant voltage across the nonlinear varistor during the burst.

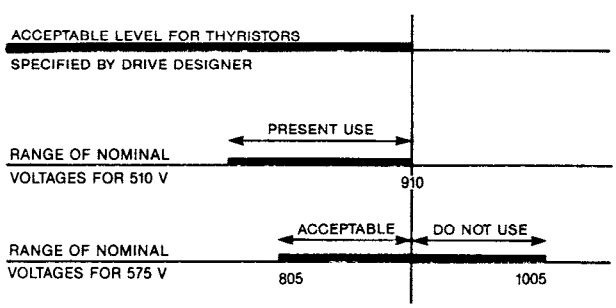
Figure 11. Tolerances bands of 510 V and 575 V varistors

Of course, the standard varistor product line has a certain tolerance band, reflecting normal production lot variations. In principle, a selection could be requested from the manufacturer that varistors with a narrower band be supplied for this application. The maximum clamping voltage allowed by the drive specifications would be retained, but those varistors in the lower half of the distribution, which draw larger current pulses for a given open-circuit transient voltage, would have been removed from the population of varistors. For instance, the range of nominal voltages for a 575 V, 32 mm varistor (the next higher voltage offered) is 805 to 1005 V for 1 mA dc, while the maximum nominal voltage of the same diameter but rated 510 V is 910 V for 1 mA dc. Thus, for a normal distribution of nominal voltages of the 575 V varistor, 50% of the devices could theoretically be used without exceeding the upper limit of the 510 V varistor that is consistent with the drive specifications. To achieve this end, it would be necessary for the supplier or user to make a careful determination of the nominal voltage on a population of 575 V varistors in order to retain only the lower half of the distribution (Figure 11).

Further gains could be obtained in the length of time between varistor failures by increasing the clamping voltage of the varistors. This increase would result in lower current pulses for the same open-circuit transient voltage. A 510 V rating had been selected by the designer of the drive as the result of a trade-off between varistor clamping voltage and the withstand voltage of the thyristors protected by the varistors. If thyristors with higher voltage withstand were used, the solution would be easy.

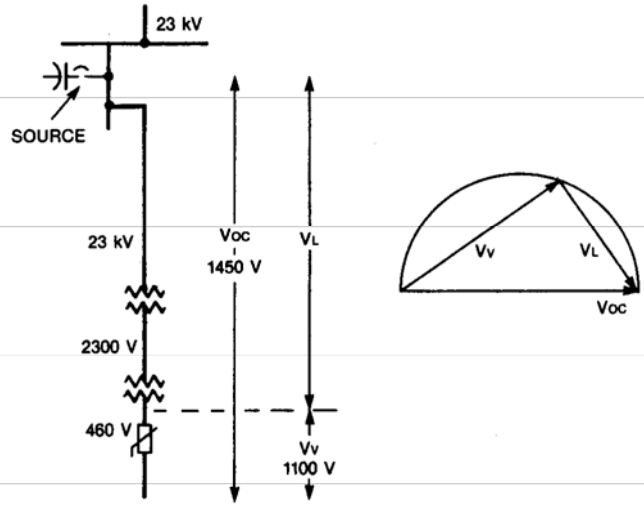
Figure 12. Open-circuit voltage and voltage drops in the system

1. From the actual measured voltages shown in Figure 12, we derive the voltage drop, V_L, in the 23 kV line and two step-down transformers:

$$V_L = (1450^2 - 1100^2)^{1/2}$$
$$= 940$$

Thus, at 5.5 kHz, the impedance between the source and the varistor is

$$Z_L = \frac{V_L}{I}$$
$$= \frac{940\ \text{V}}{200\ \text{A}}$$
$$= 4.7\Omega$$

Note that this 4.7Ω impedance means that the 5.5 kHz switching transient, generated at a distance of about 3000 m (2 miles) from the point of measurement, and at the 23 kV level, can travel a long distance and pass through two step-down transformers with less attenuation than might be expected from the unsound but popular view that "surges cannot travel that far without substantial attenuation."

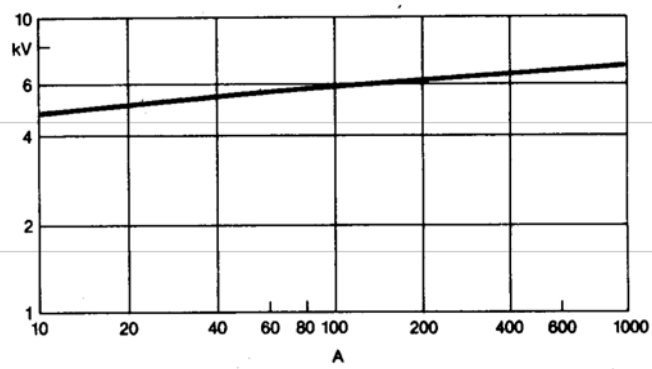
Figure 13. Minimum clamping voltage characteristic for 2300 V arrester

a) Assume a current crest of 50 A, producing a drop of $50 \times 75 = 3750$ V in the line and 23,000/2300 V transformer. Adding this voltage to the varistor voltage, corresponding to 50 A, which is read as about 5700 V on the arrester characteristic curve for minimum discharge voltage (Figure 13), we have $(3750^2 + 5700^2)^{1/2} = 6780$ V, or somewhat below the expected 7250 V open-circuit voltage, which is to equal the quadratic sum of the two voltages V_L and V_V.

Furthermore, the 5700 V clamping level predicted for the 2300 V surge arresters at 60 A would be reflected as a crest of $5700\ \text{V} \times 460/2300 = 1140$ V on the 460 V side. The 510 V, 32 mm varistors, connected in series with the impedance of the 2300/460 V transformer, would then be exposed to this maximum open-circuit voltage of 1140 V, a value much lower than the 1450 V open-circuit voltage that was applied to them in the absence of the 2300 V arresters. For that applied voltage, the current drawn by the varistor would be in the range of 10 to 20 A, values much lower than the 200 A measured without the 2300 V arrester. Computing the equivalent pulse, as was done in Figure 10 for the 200 A crests, would yield an equivalent crest of about 10 A, for which the pulse rating curves of the 32 mm series show more than 100,000 pulses before its rating is reached.
